Bridge No. 008-4/5-2.95(01215)

PFC Abraham G. Sams Memorial Bridge

over ELK RIVER

BRIDGE INSPECTION REPORT

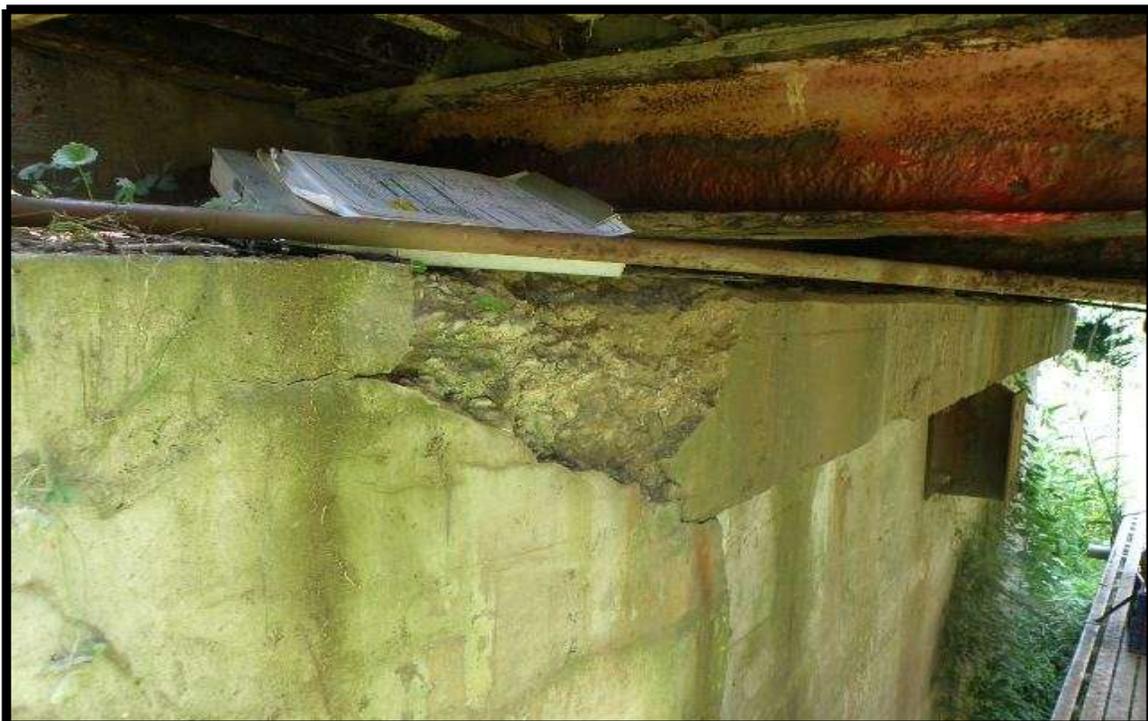
- Light to moderate spalling to the edge of the bridge seat, especially around the sight of previous core holes and on the upstream side beneath Stringer One (see **Photo 6**).
- The seat and top of the upstream wingwall which was previously repaired exhibits hairline map cracking.
- The top of the downstream wingwall at the backwall union is broken out and has fallen away; someone has shoveled blacktop to fill the gap, no repair is needed at this time.

PHOTO 6 - SPALLING TO SEAT FACE OF ABUTMENT ONE UNDER STRINGER ONE (18" IN LENGTH. NOT AFFECTING THE BEARING)

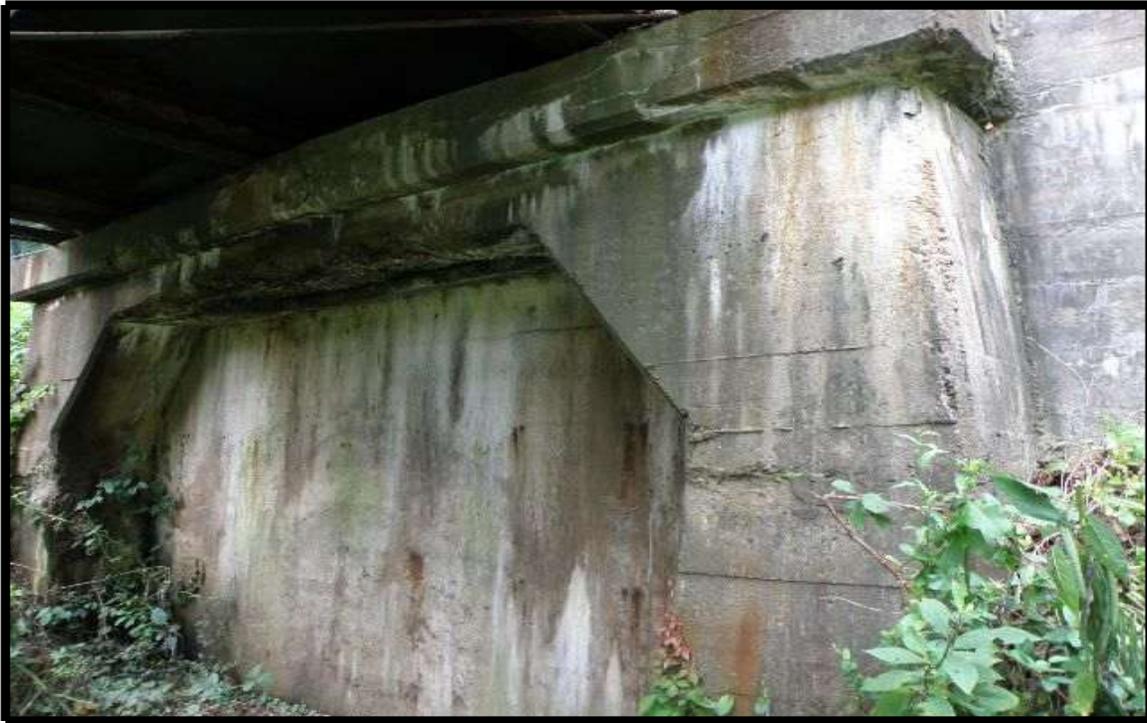
This full height reinforced concrete abutment with extended wing walls is in poor condition and features a recessed breast wall/backwall creating the appearance of columns beneath the truss bearings (see **Photo 7**).

PHOTO 7 - OVERALL OF ABUTMENT TWO

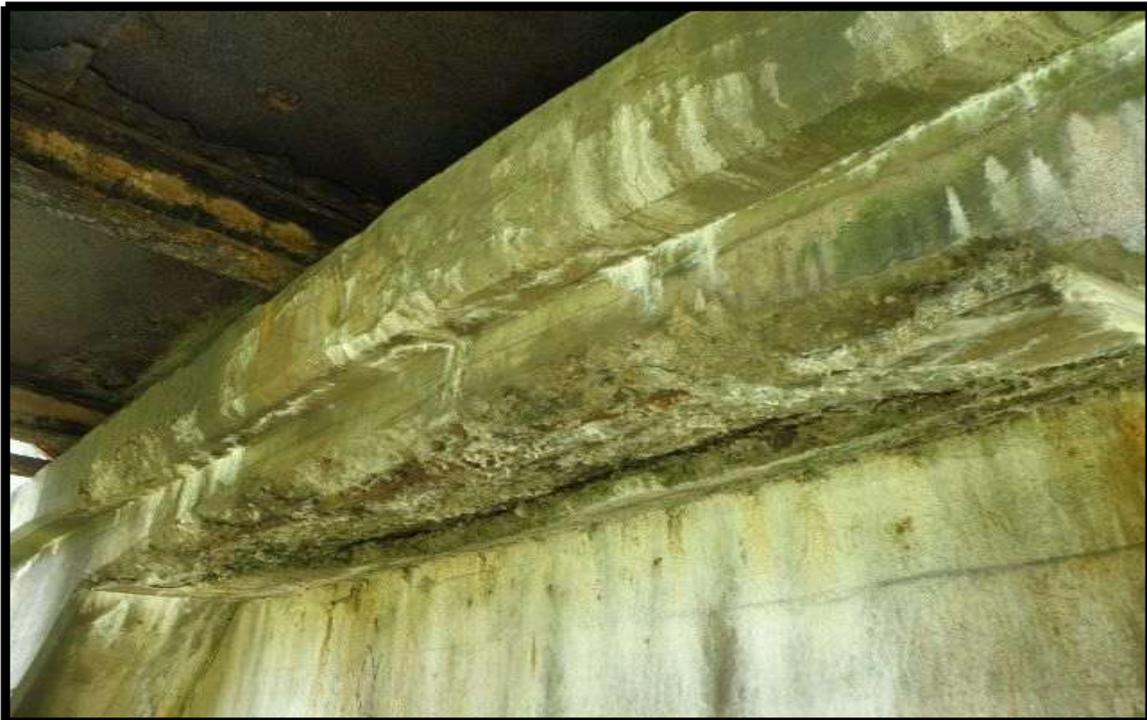
- The underside of the seat exhibits large rebar exposing spalls, delamination and general disintegration/failure of the paste (see **Photo 8**).
- Moderate to heavy spalling of the concrete exists along a cold joint in the upstream and downstream columns respectively (see **Photo 9**).
- The seat face displays hairline to 1/8" wide map cracks and efflorescent stains.
- All exposed concrete surfaces are weather worn and exhibit random hairline cracks and efflorescent stains (see **Photo 10**).
- The backwall edges are chipped away exposing the aggregates.

PHOTO 8 - SEVERE DETERIORATION OF CONCRETE & EXPOSED REBAR, ABUTMENT TWO

7. The cracked and spalled areas of the substructure units should be repaired.
8. All loose truss members should be tightened and the entire structure cleaned and painted.

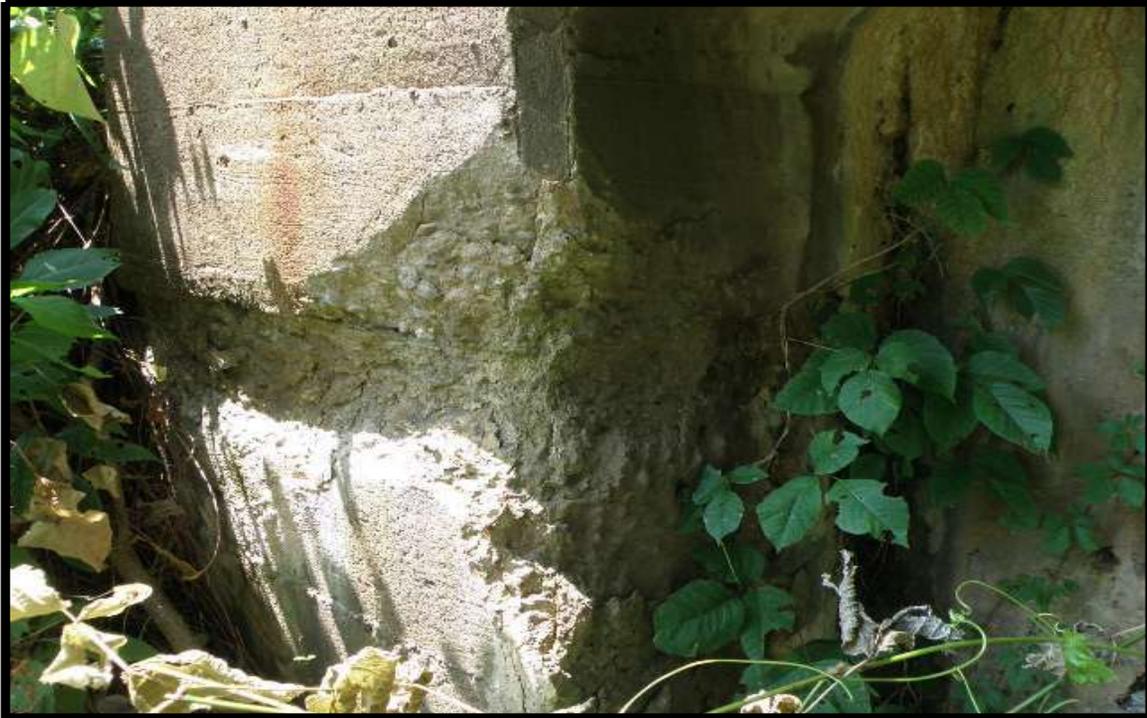
PHOTO 9 - SPALLING ALONG COLD JOINT IN COLUMN ONE OF ABUTMENT TWO

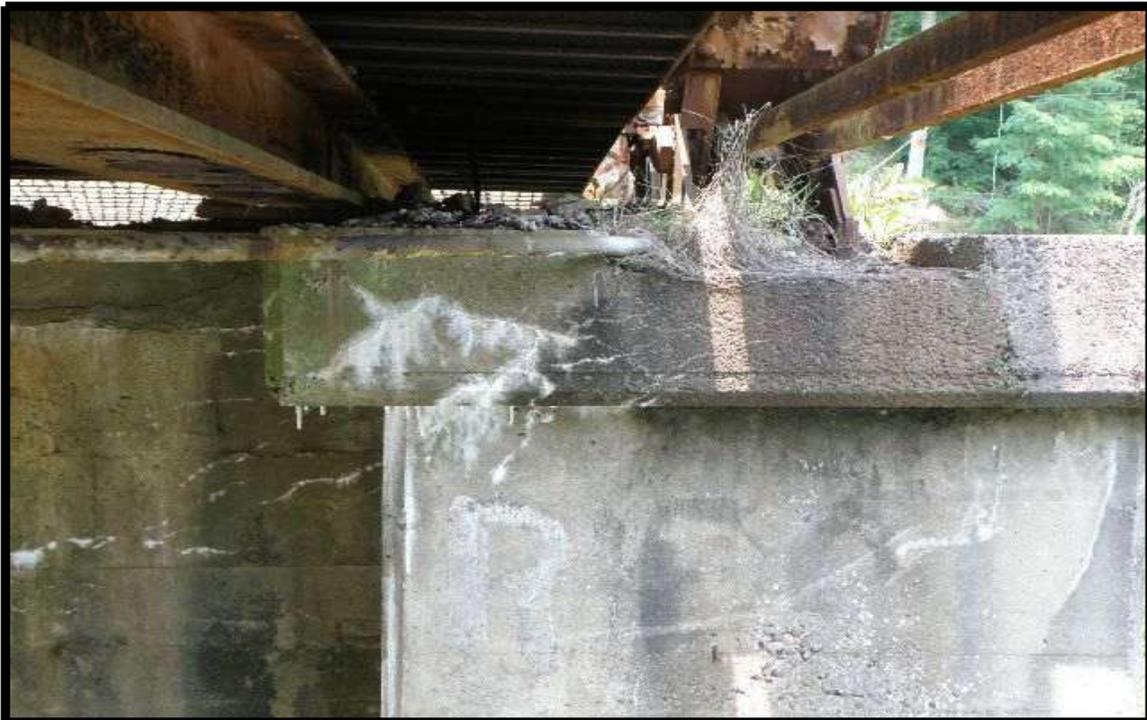
PHOTO 10 - MAP CRACKING WITH EFFLORESCENCE, REAR SIDE, COLUMN TWO OF ABUTMENT TWO

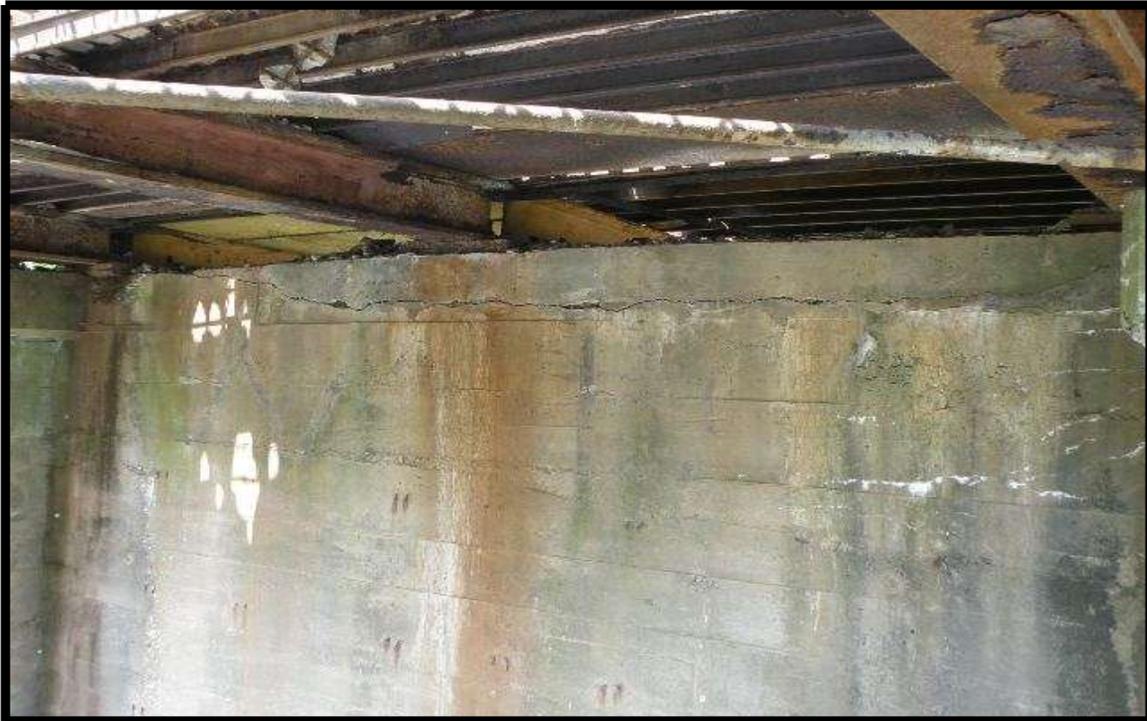
· A horizontal crack up to 5/16" in width extends nearly the full length of the seat on both the rear and forward side of the pier. It should be noted that the crack runs along the edge of a previous repair to the cap and the concrete is fairly solid (**see Photo 11**).

PHOTO 11 - UP TO 5/16" CRACK ALONG REAR OF PIER TWO'S CAP (SEAM OF FORMER REPAIR) TYPICAL OF FORWARD SIDE AS WELL

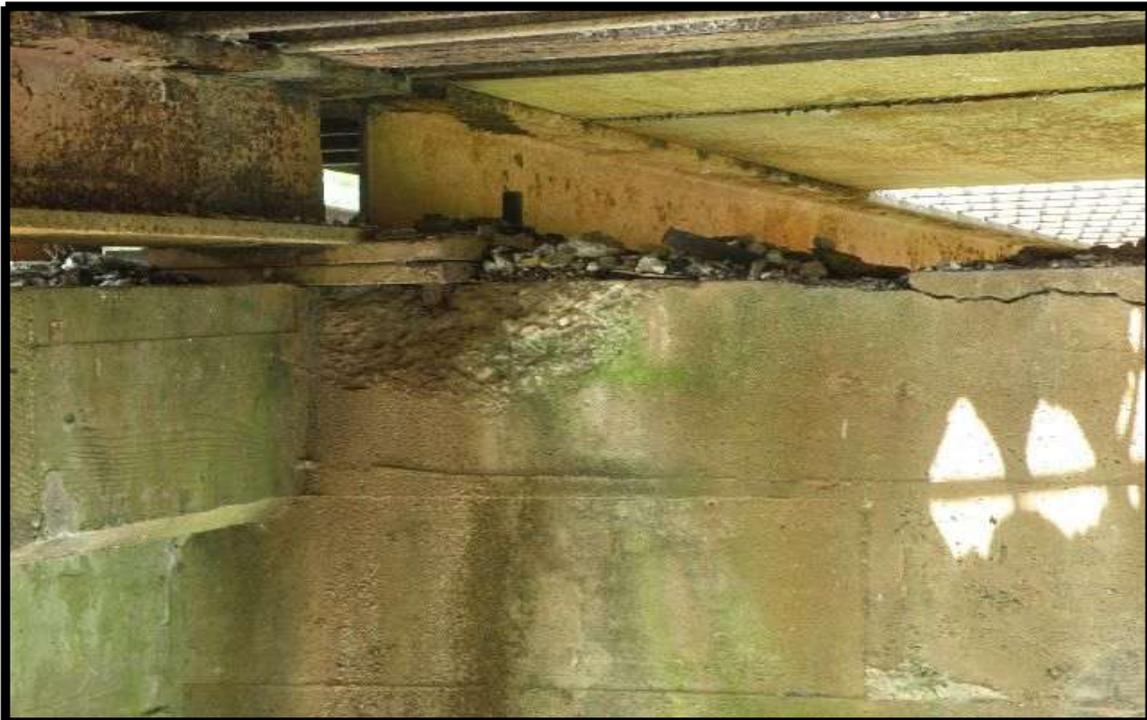
· A small area of the seat has failed beneath the bearing plate of Stringer One on the rear side, having no effect on the bearing at this time (**see Photo 12**).

PHOTO 12 - SPALLING UNDER BEARING AREA, SPAN TWO UNDER STRINGER ONE (BEARING REMAINS SUPPORTED)

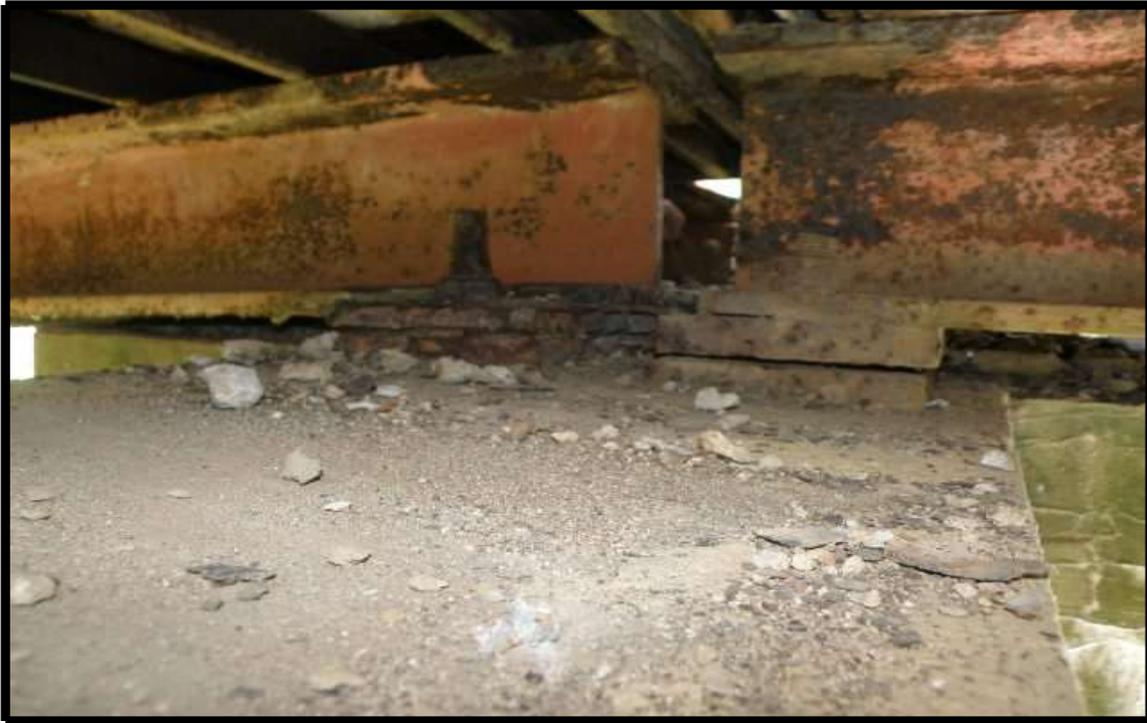
All of the bearings on the entire structure are corroded and show no indications of movement during expansion and contraction (**see Photo 13**). The bearing shoes of Span Two (Main Span) are heavily rusted over Pier Two and the roller nests over Pier One are corroded and frozen.

PHOTO 13 - TYPICAL CONDITION OF BEARINGS

5. Span Ones Downstream Truss should be monitored during each future inspection.
6. Replacement of the frozen roller nests over Pier One and any deteriorated bearing plates is recommended.

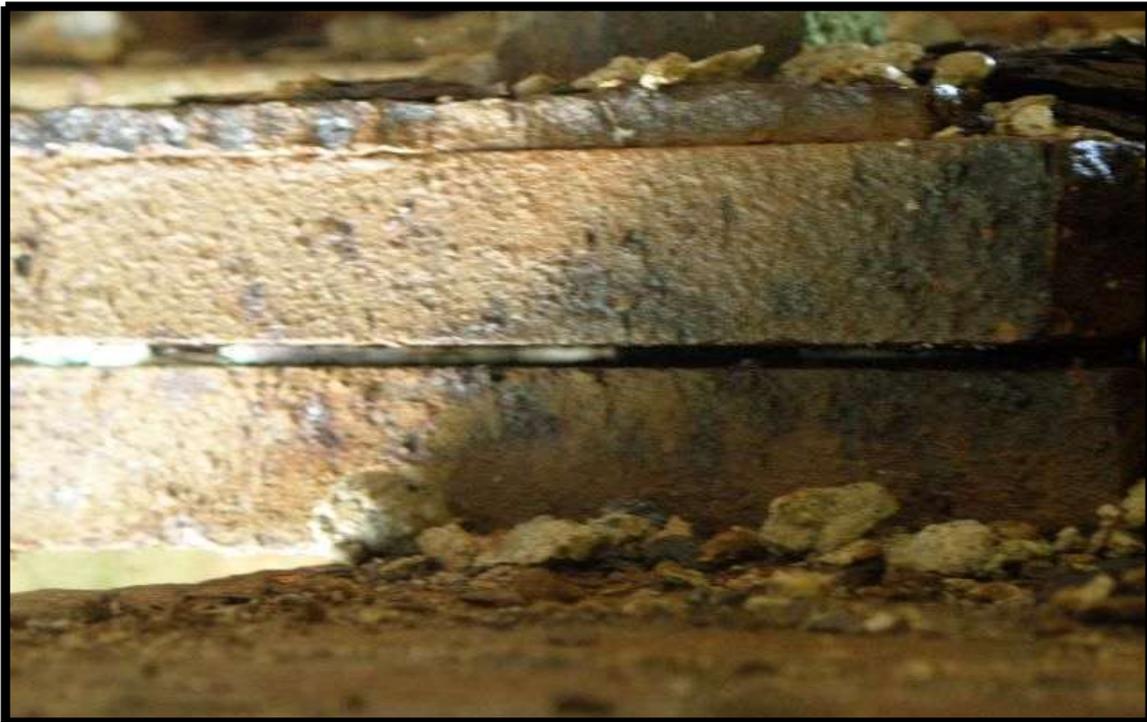
We also found the stringers over the piers appearing to be floating slightly above their respective masonry plates, suspended from the grid deck. However, we did not observe any excessive movement under load. Previous reports have stated that this gap was 1/8" to 5/16". It appears that the failure and subsequent repairs of the grid decking at each pier has actually helped this situation, allowing the stringers to settle on to the bearing plates, somewhat, as the gap is now about 1/16" (see **Photo 14**).

PHOTO 14 - STRINGERS @ PIER TWO NOT RESTING ON SOLE PLATE

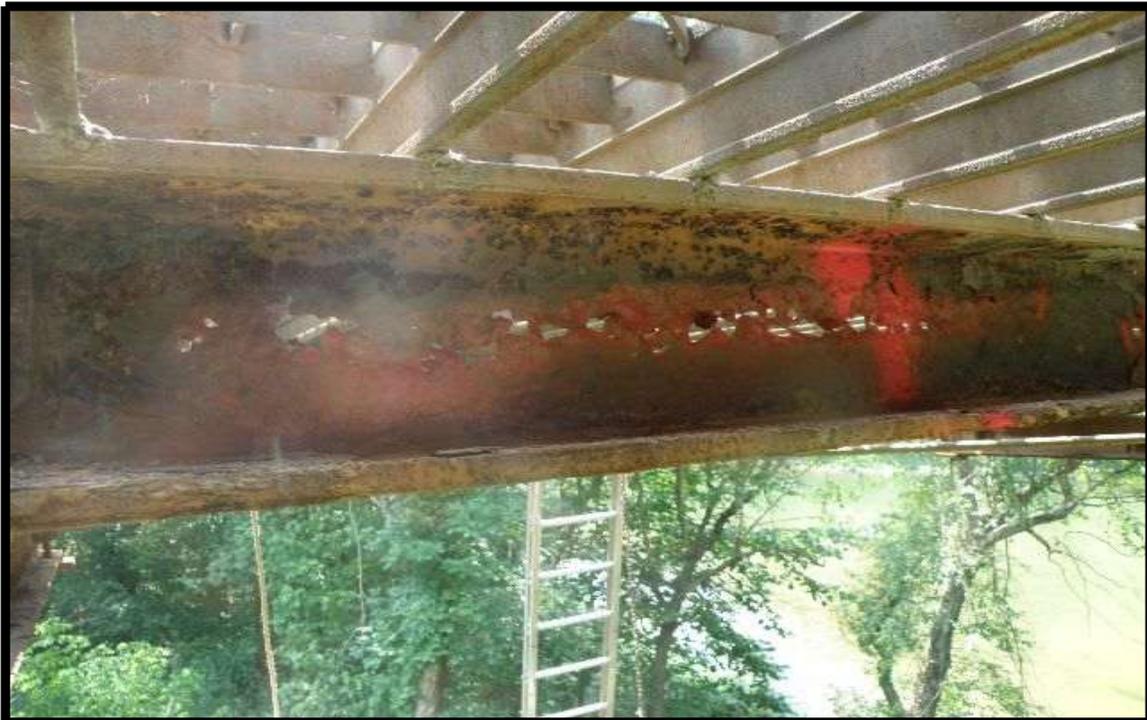
Stringer Twos Web is now failing (81% Web Loss) in Panel Four and most of Panel Five (see **Photo 16**) (**Work Order**).

PHOTO 16 - FAILED WEB STRINGER TWO, PANEL 4, SPAN ONE

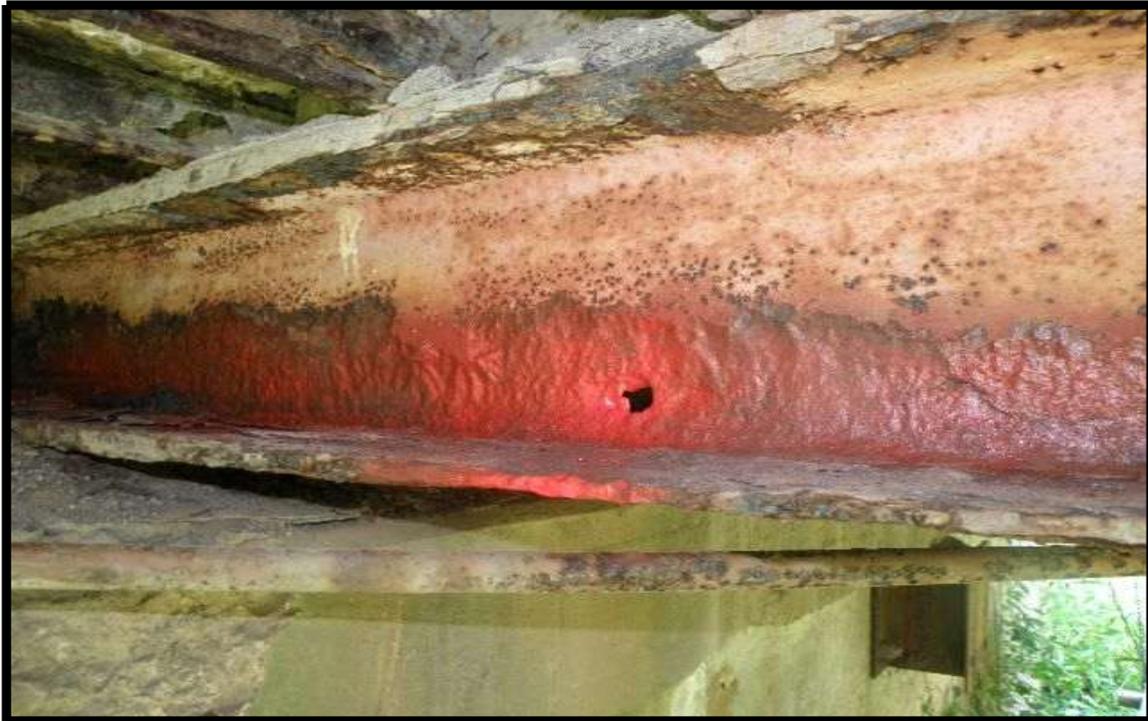
PHOTO 17 - DETERIORATION TO STRINGER THREE @ ABUTMENT ONE

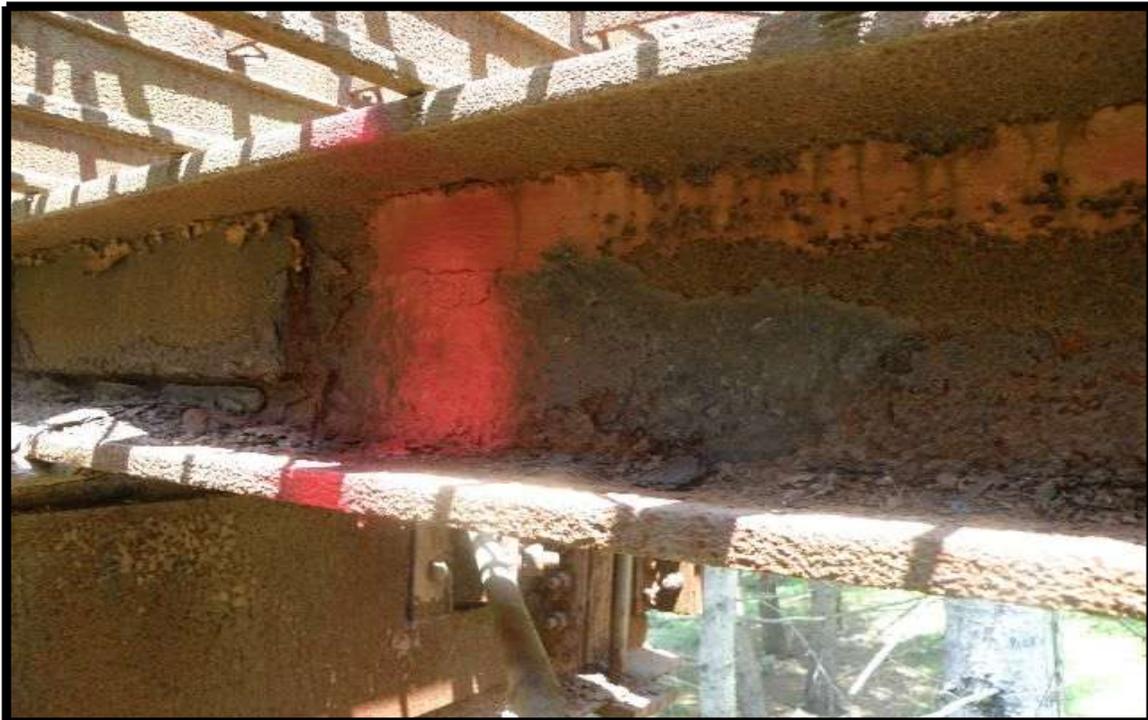
Stringer Three also displays random areas of deterioration (see **Photo 18**) primarily to the upstream side of the web, requiring no repair at his time.

PHOTO 18 - DETERIORATION STRINGER THREE, PANEL TWO, SPAN ONE

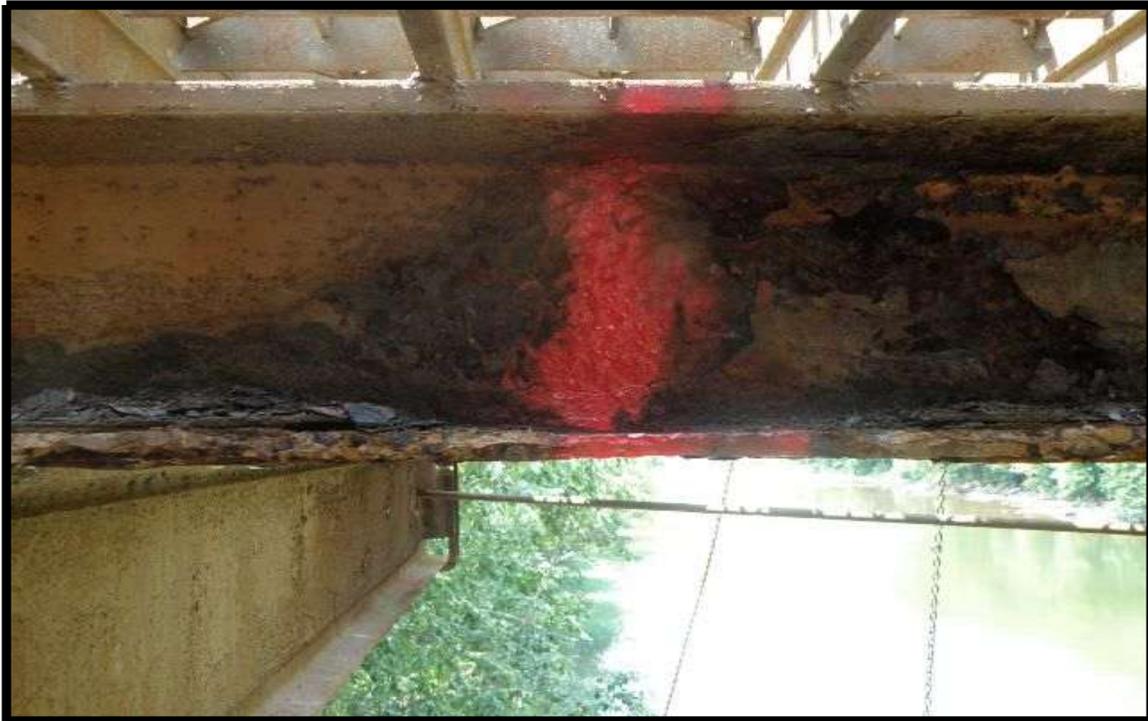
Stringer Twos Web has moderate to heavy deterioration primarily to the upstream side ranging from 35% to 50% Loss and extending for the full length of all panels with the exception of Panels Five and Seven which have no significant loss. Total Losses for Stringer Two in this Span is 26% or less (see **Photo 19**) as both of the flanges are good for nearly the entire span.

PHOTO 19 - STRINGER TWO, SPAN TWO, PANEL TWO SECTION LOSS

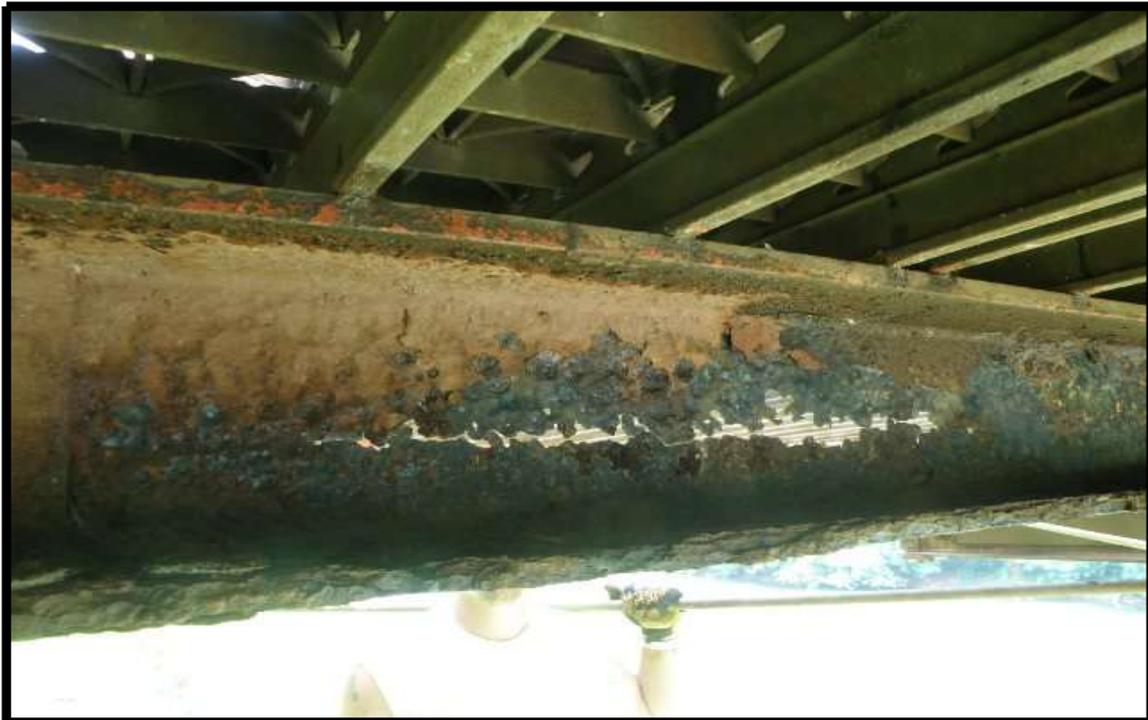
Stringer Two Web is failing for the entire length of Panel Four and part of Panel Five (see **Photos 20 and 21**) (**Work Order**).

PHOTO 20 - FAILED WEB, STRINGER TWO PANEL FOUR, SPAN THREE

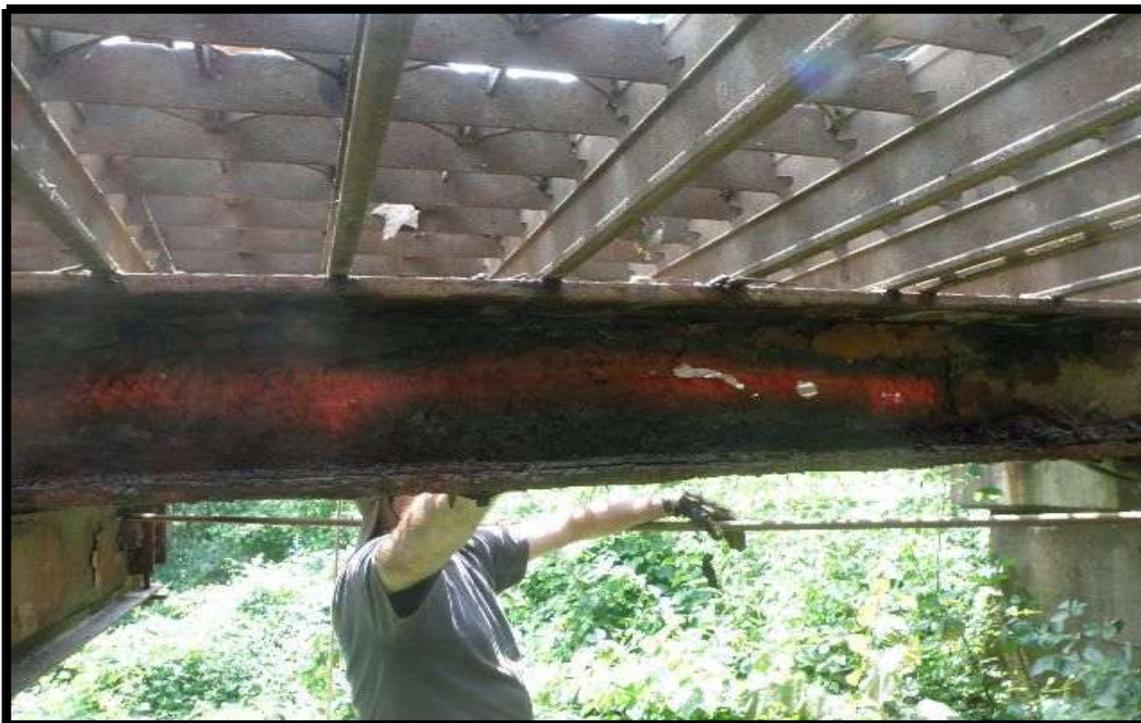
PHOTO 21 - FAILED WEB, STRINGER TWO PANEL FIVE, SPAN THREE

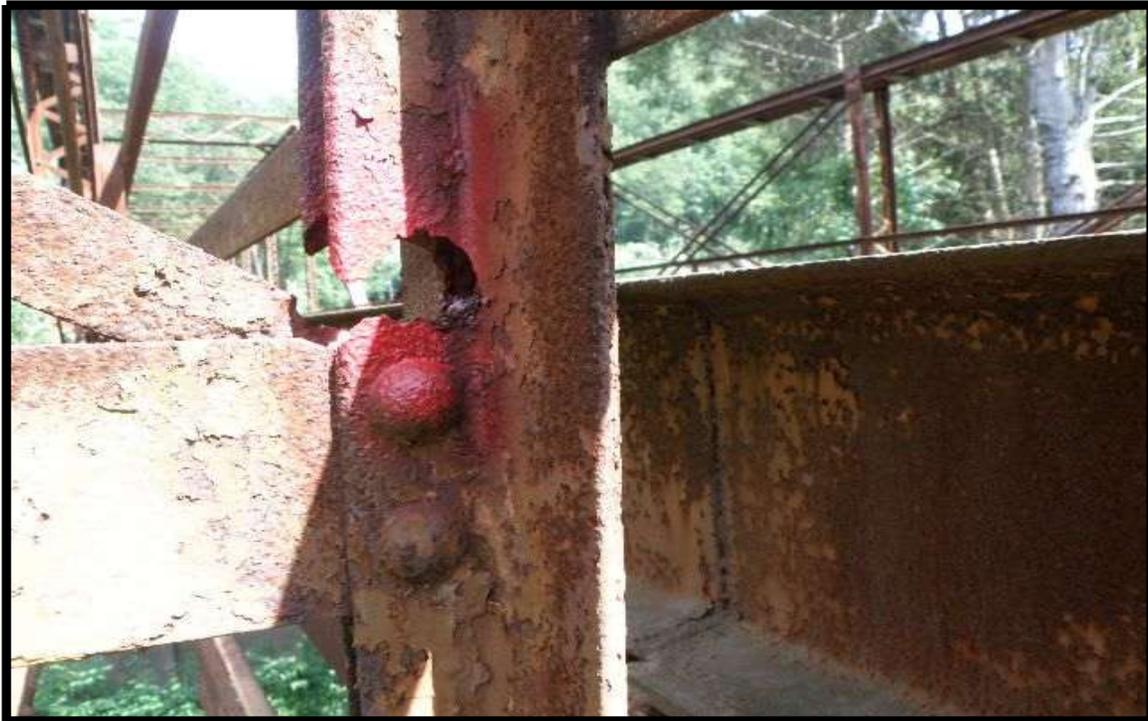
Vertical members in these spans are in fair condition; with losses primarily to the hip verticals U1-L1 and U4 – L4, which are in tension. The worst of these being the U1 – L1 of the Downstream Truss in Span One (see **Photo 27**) However, this member has been previously retrofitted; with the addition of steel plates on both the upstream and downstream sides of the member and needs no attention at this time.

PHOTO 27 - DETERIORATED ANGLES U1 - L1 VERTICAL, SPAN ONES DOWNSTREAM TRUSS (RETROFITTED)

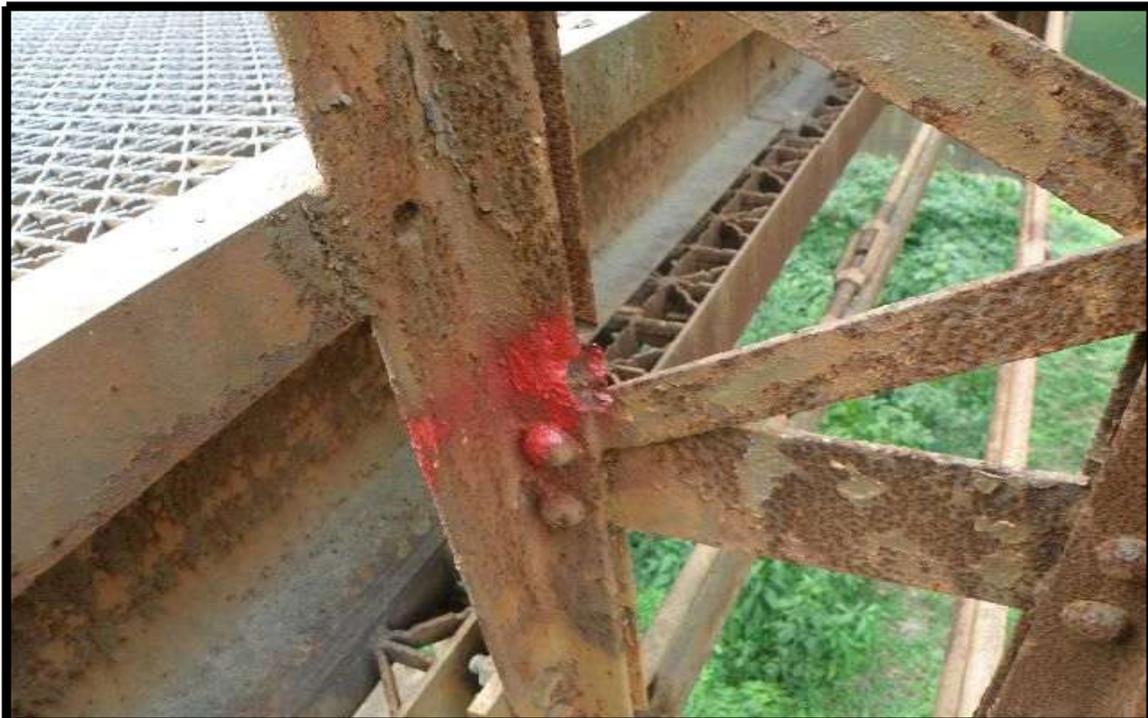
PHOTO 28 - U1 - L1 VERTICAL, SPAN ONES UPSTREAM TRUSS 21% TOTAL LOSS (U4 - L4 VERTICAL. SAME TRUSS SIMILAR APPEARANCE 15% TOTAL LOSS)

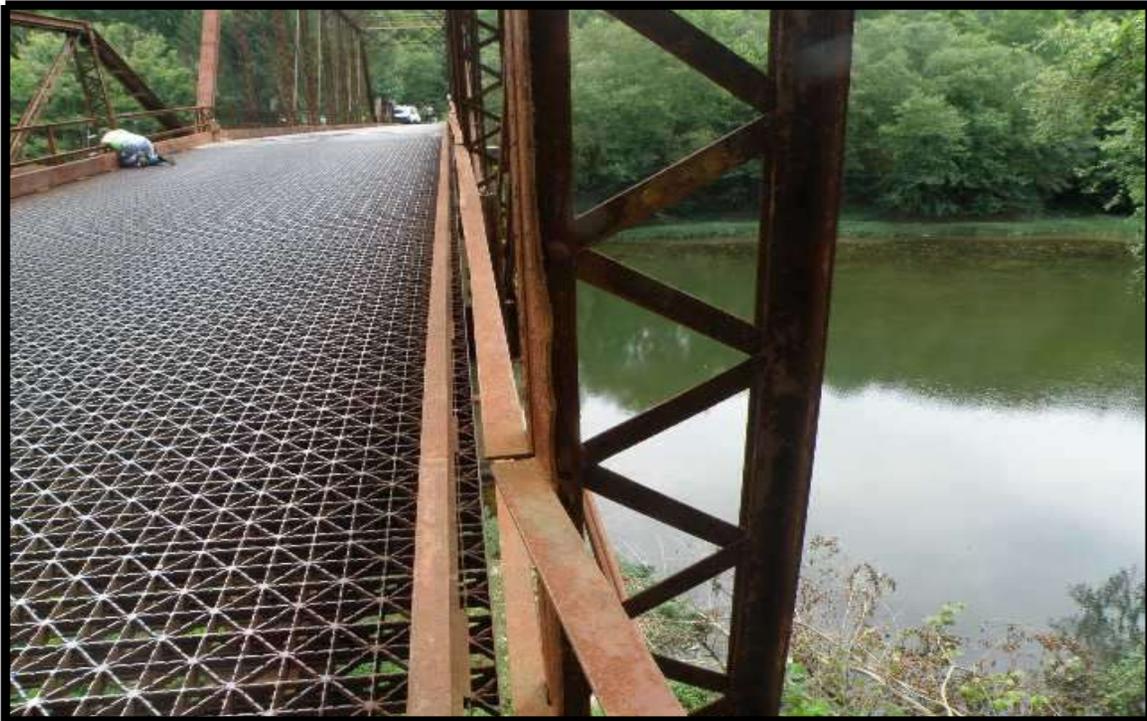
The U4 – L4 vertical member in Span Threes Downstream Truss has collision damage which should have little effect on function (see **Photo 29**)

PHOTO 29 - COLLISION DAMAGED INTERIOR ANGLE OF U4 - L4 VERTICAL, SPAN THREE

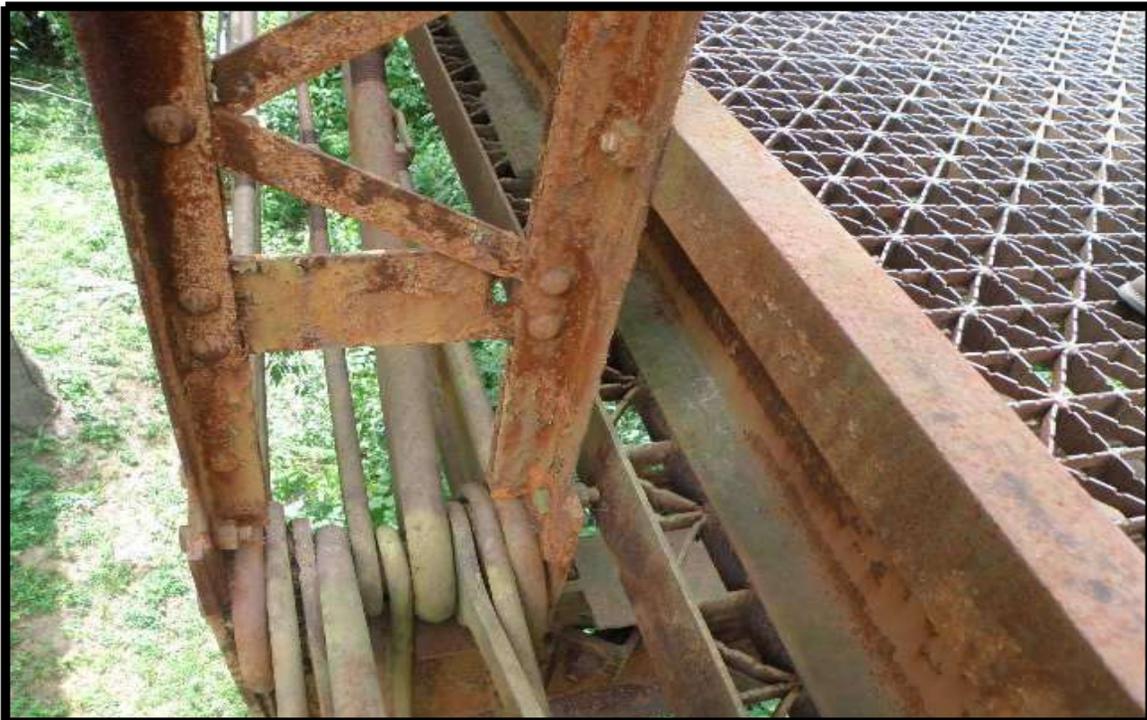
The other vertical members of these two spans have no significant deterioration with the exception of moderate loss to a few of the batten Plates (see **Photo 30**)

PHOTO 30 - HOLE IN BATTEN PLATE U3-L3 VERTICAL OF SPAN ONES UPSTREAM TRUSS APPROXIMATELY 30% LOSS (WORSE EXAMPLE IN THESE SPANS)

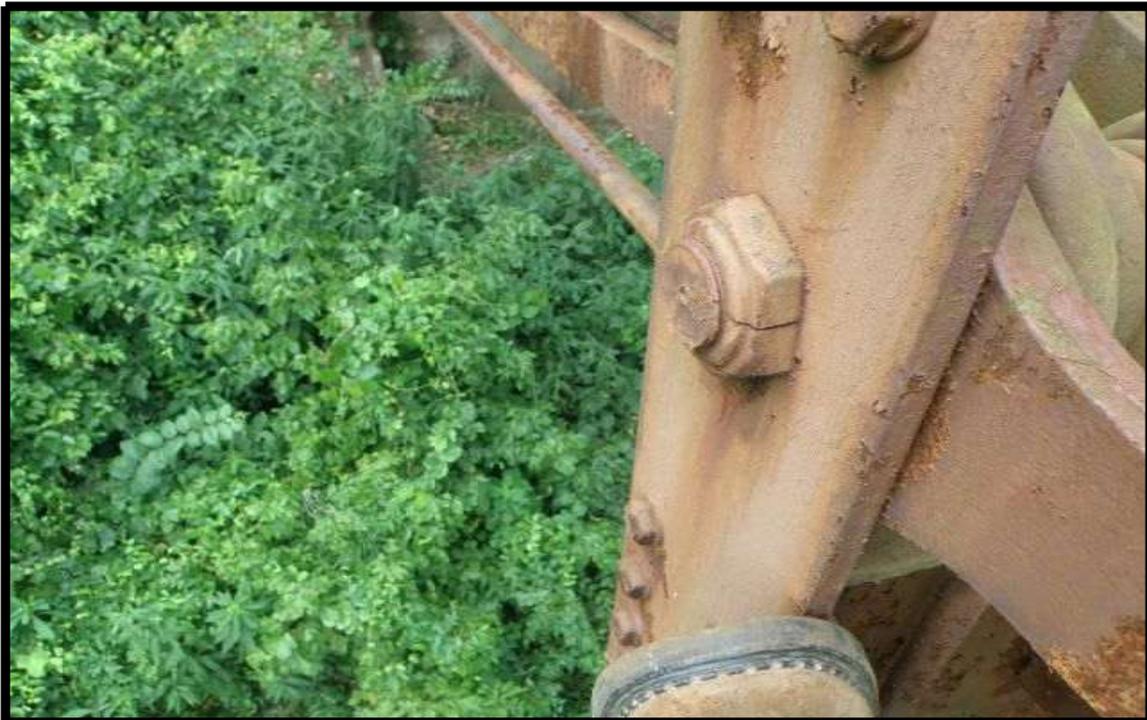
PHOTO 37 - FAILED PIN RETAINER NUTS(TAKEN @ L1, SPAN ONE UPSTREAM L4, SPAN THREE DOWNSTREAM SIMILAR)

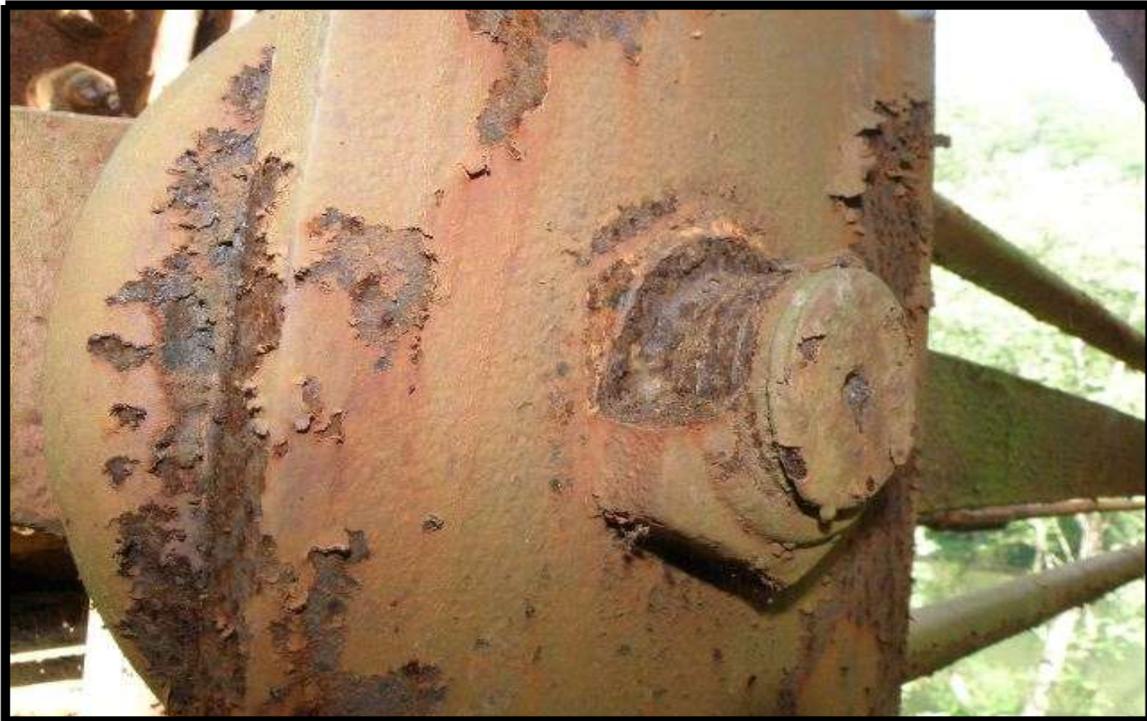
PHOTO 38 - DETERIORATED HANGER BOLT @ FLOORBEAM FOUR, SPAN ONE, UPSTREAM

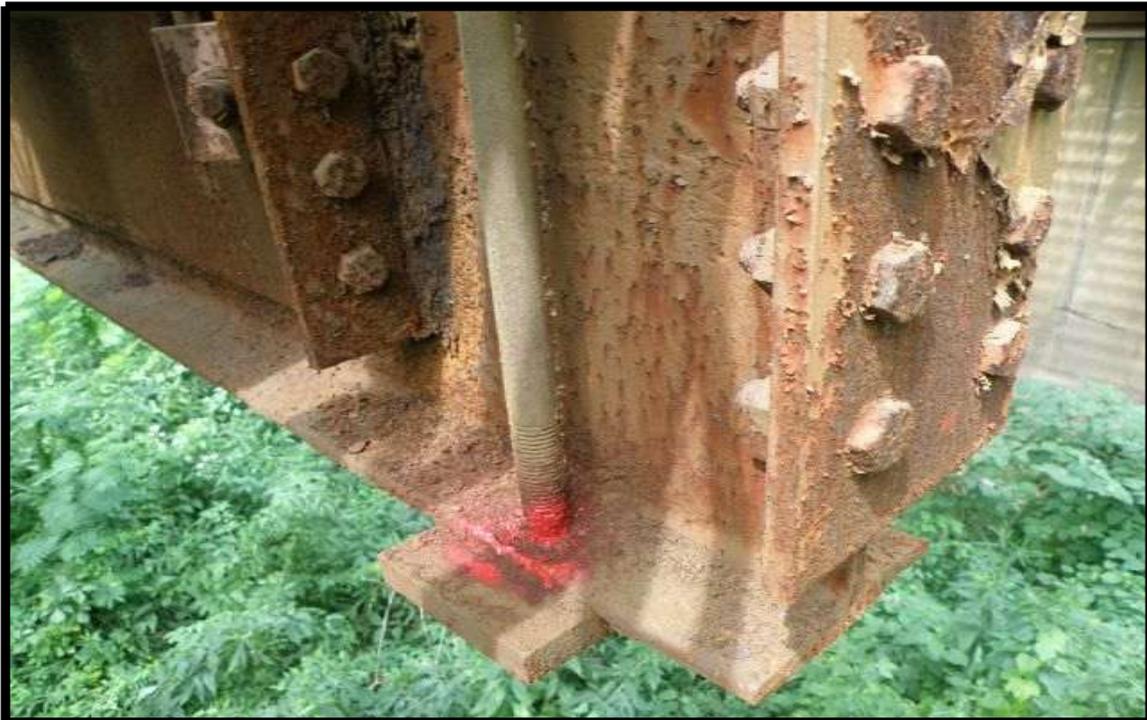
PHOTO 39 - DETERIORATED LATERAL BRACING

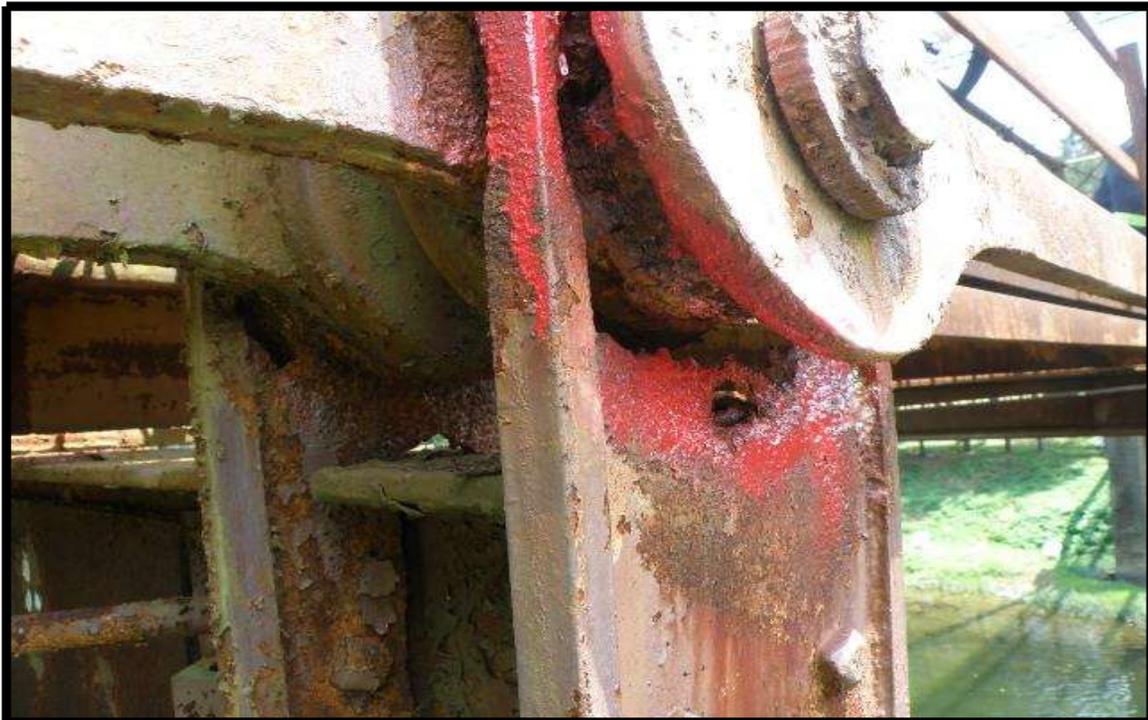
PHOTO 46 - UPPER CHORD COVER PLATE 90% DETERIORATION @ U3 OF UPSTREAM TRUSS SPAN TWO & FAILED UPPER LATERAL BRACING

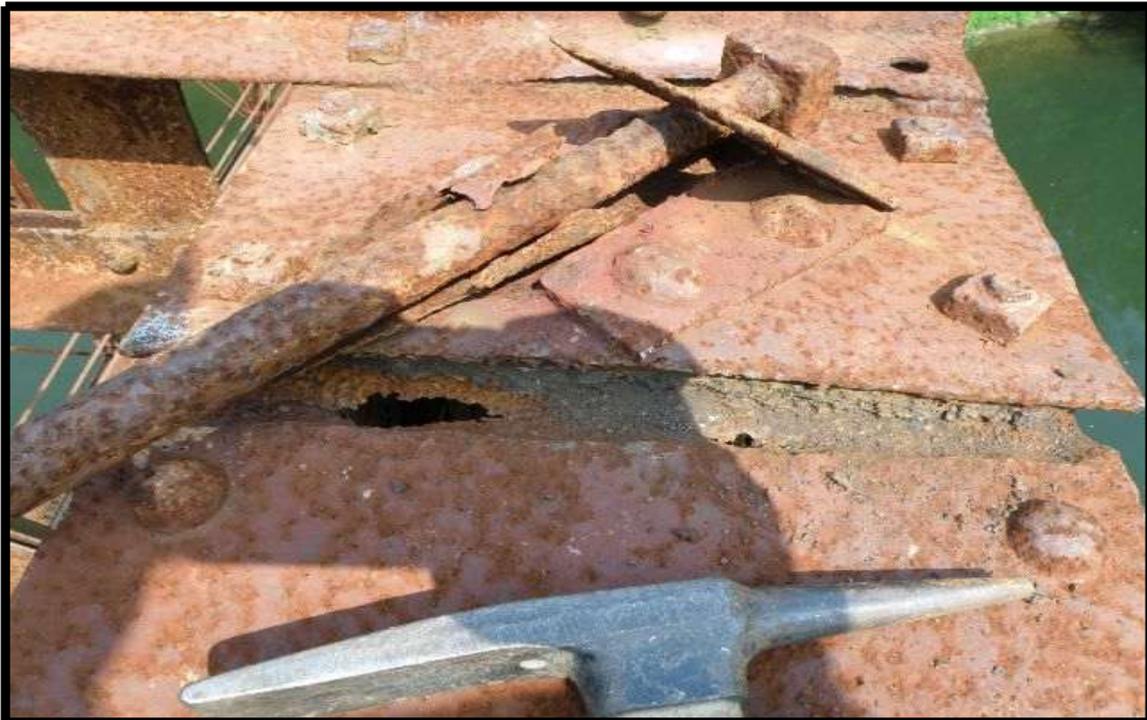
PHOTO 47 - UPPER CHORD COVER PLATE 90% DETERIORATION DOWNSTREAM TRUSS SPAN TWO @ U7. & FAILED LATERAL BRACING CONNECTION

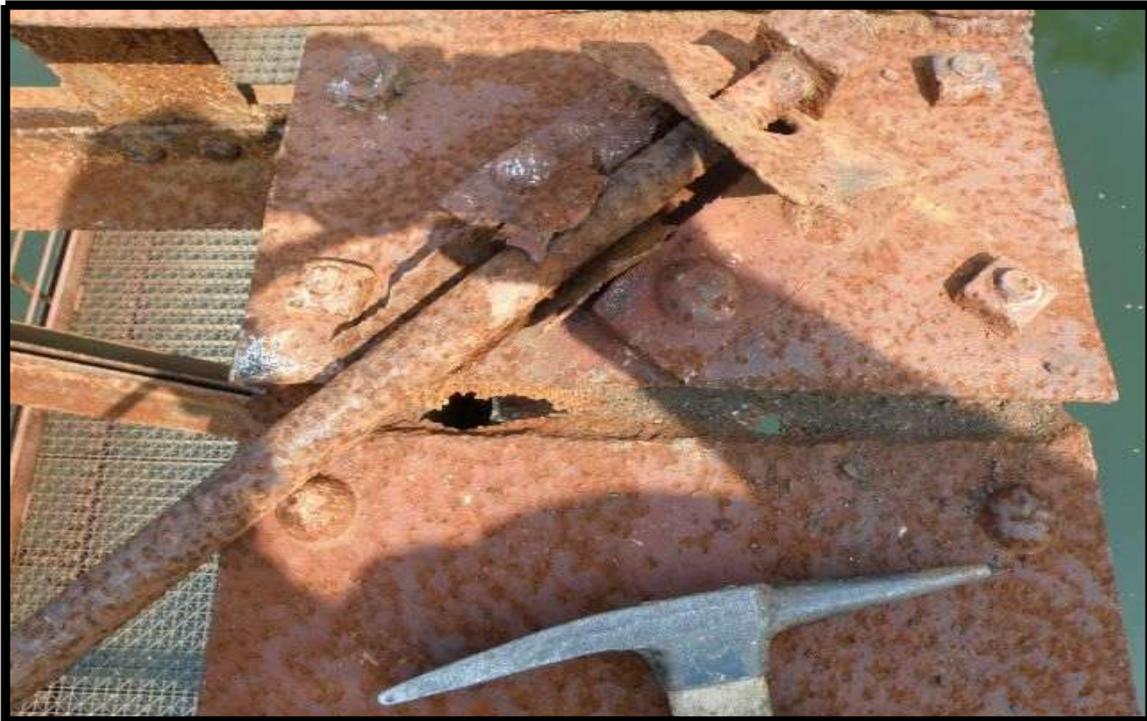
PHOTO 48 - UPPER CHORD COVER PLATE 90% DETERIORATION DOWNSTREAM TRUSS SPAN TWO
