Bridge No. 008-4/5-2.95(01215)

PFC Abraham G. Sams Memorial Bridge

over ELK RIVER

BRIDGE INSPECTION REPORT

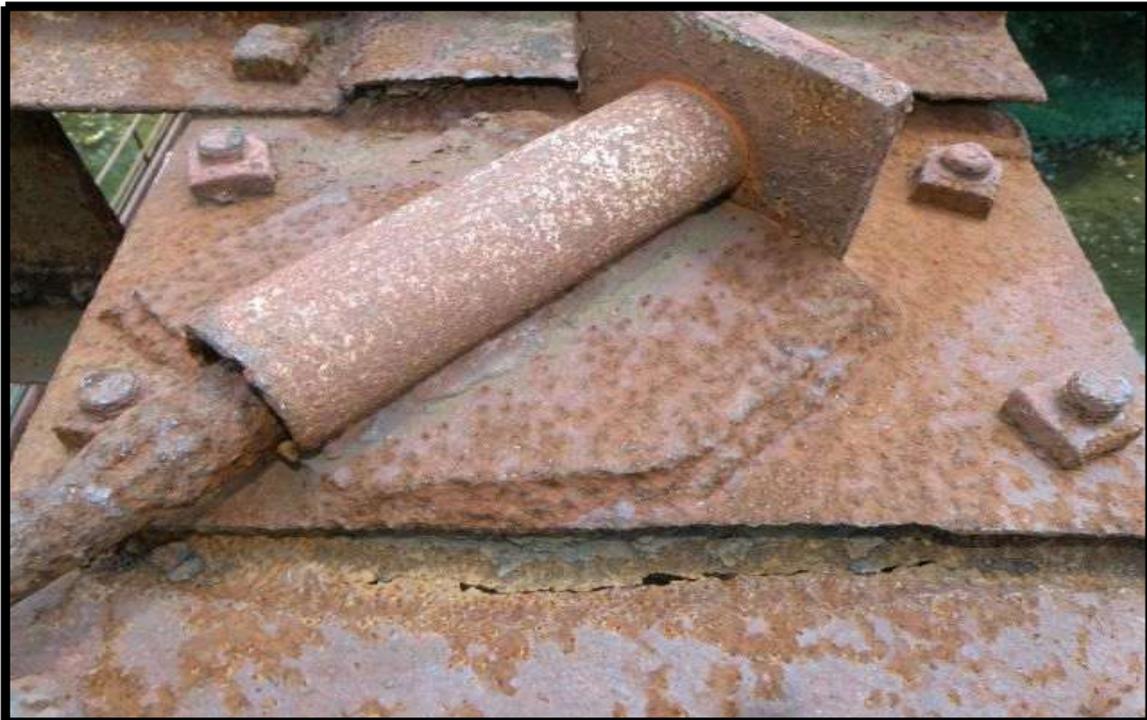
PHOTO 49 - FAILED UPPER LATERAL BRACING @ U7 UPSTREAM SPAN TWO

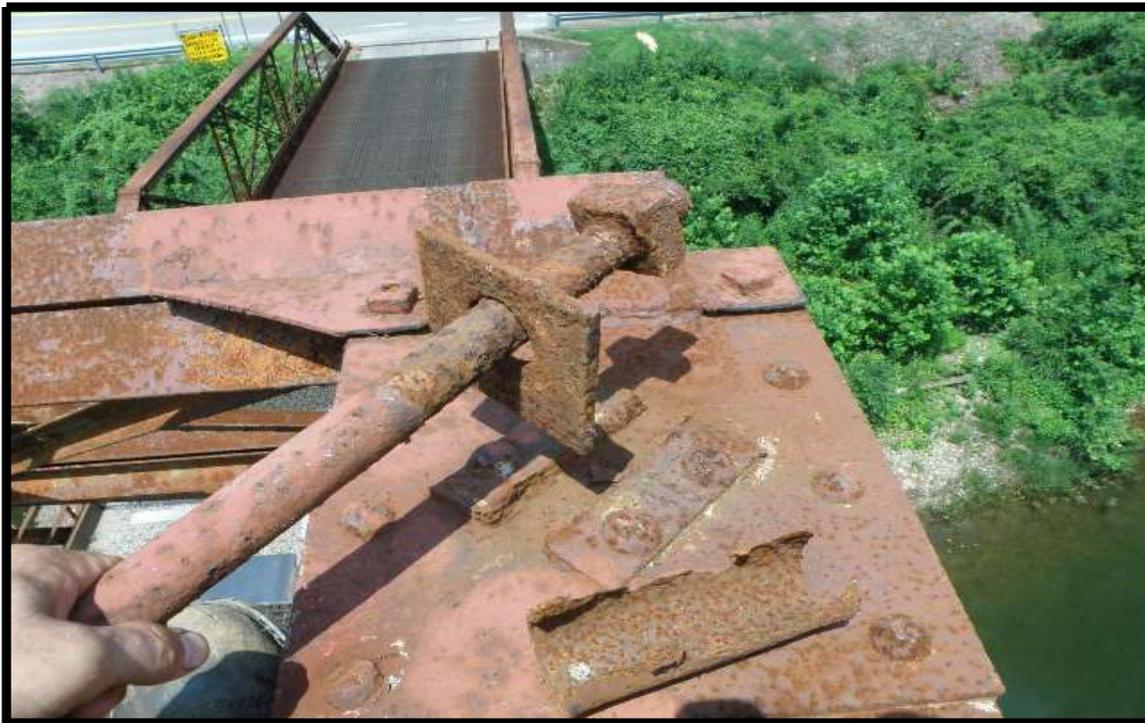
PHOTO 50 - CONDITION OF UPPER LATERALS INSIDE OF CONNECTIONS

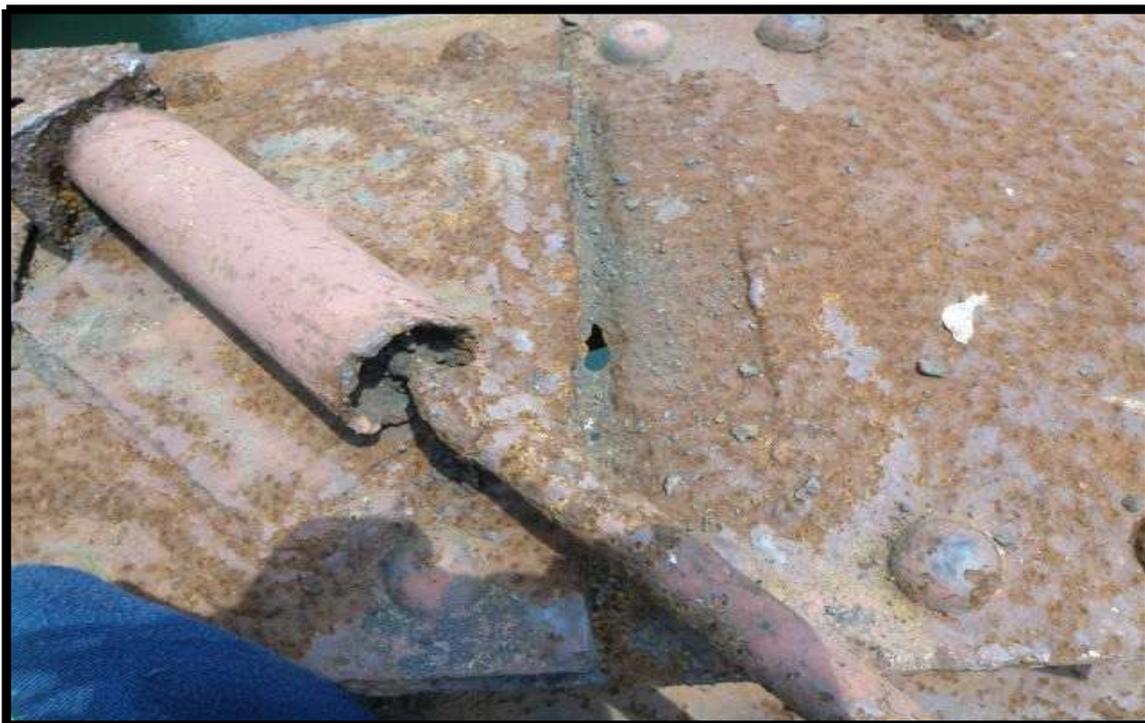
PHOTO 52 - FAILED LOWER LATERAL PANEL ONE SPAN TWO

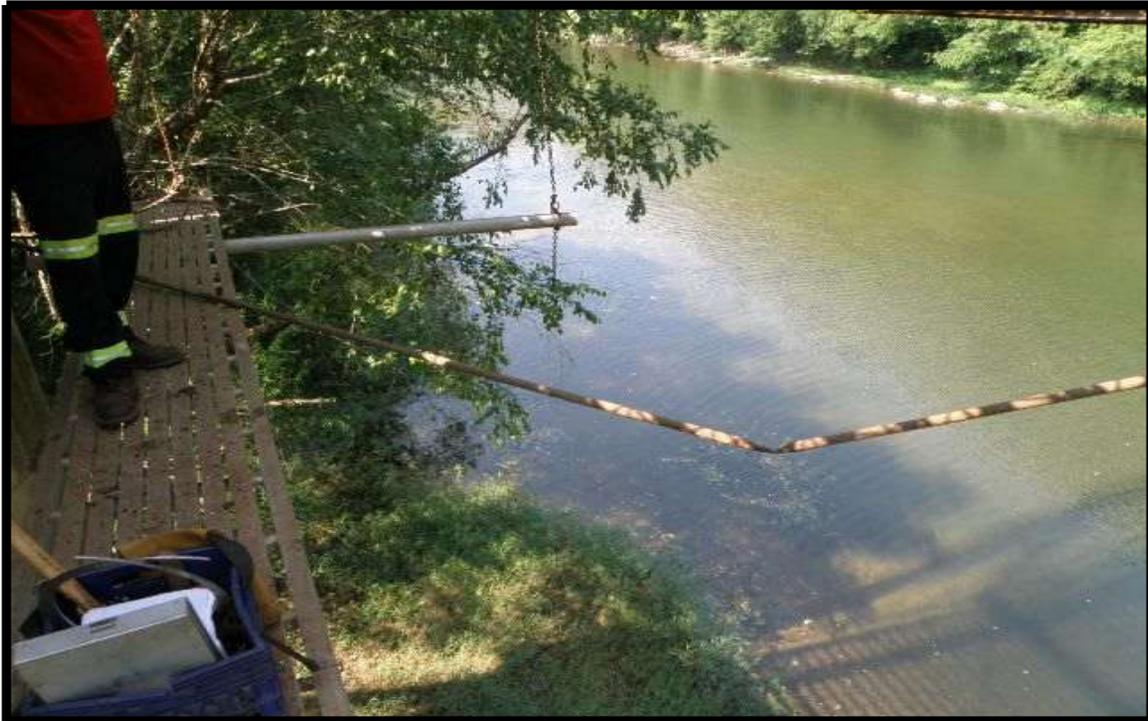
PHOTO 53 - FAILED LOWER LATERAL PANEL ONE, SPAN TWO (AFTER WE GOT IT OFF THE SCAFFOLD)

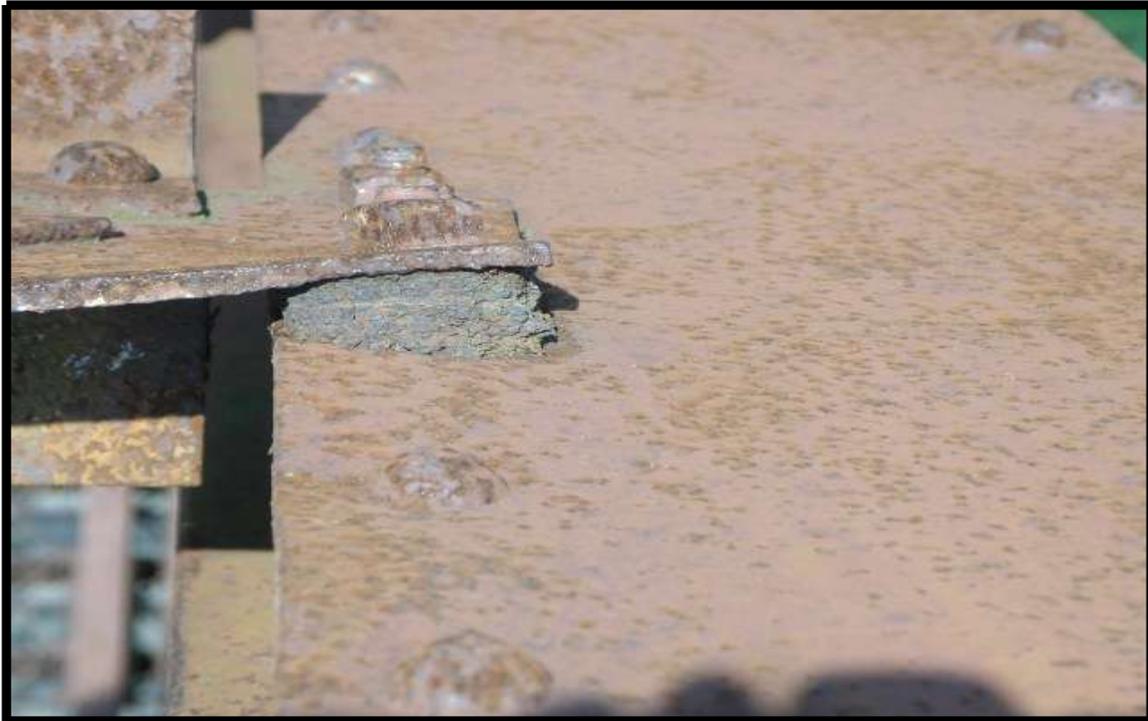
PHOTO 55 - SWAY STRUTS DETERIORATION AND BENDING FROM PACK RUST @ CONNECTIONS TO TOP CHORD (TYPICAL)

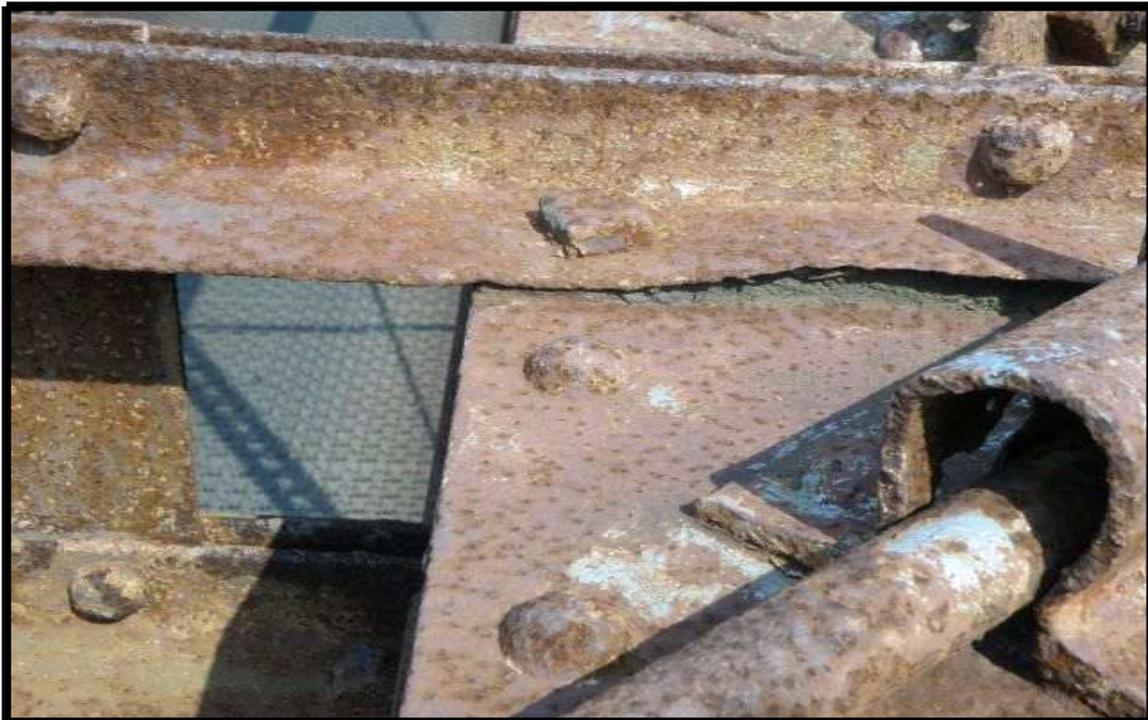
PHOTO 56 - SWAY STRUTS DETERIORATION @ KNEE BRACE CONNECTION (TYPICAL)

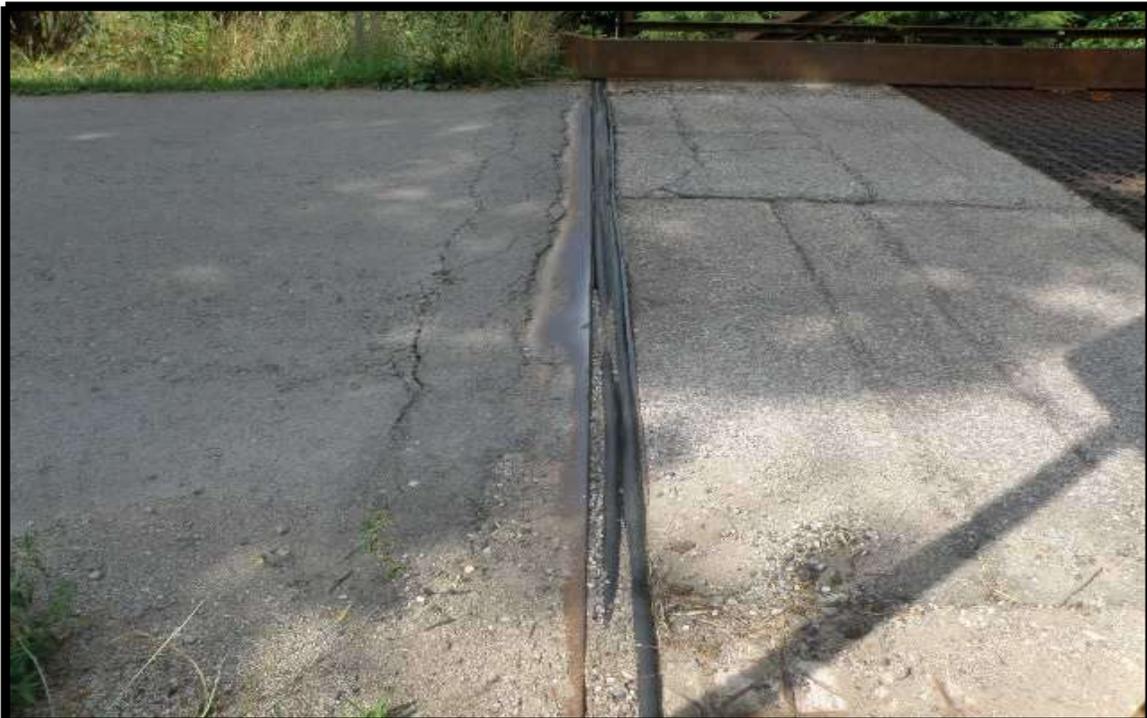
PHOTO 58 - EXPANSION DAM @ ABUTMENT TWO AND SEAL HANGING UNDERNEATH

3. Damaged and loose sections of the two line guardrail should be repaired.
4. Stringer Two at Abutment Two should be raised and the expansion seal at this location replaced.

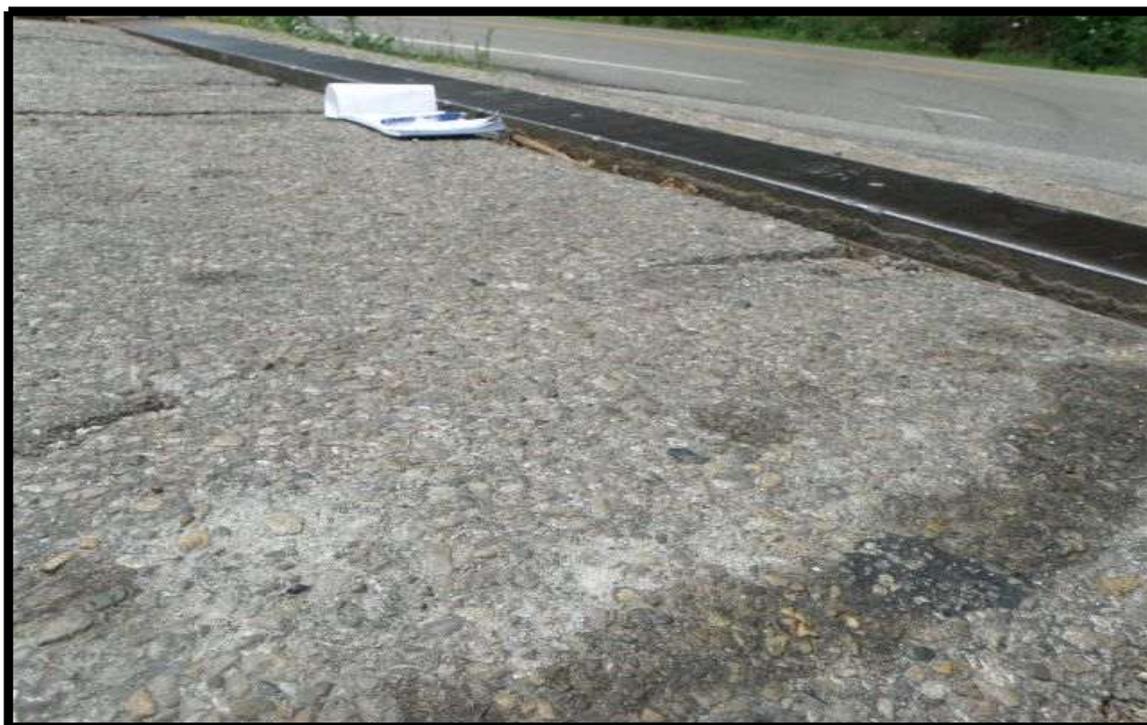
PHOTO 60 - TYPICAL OF FAILING DECK & EXPANSIONS @ PIERS (PIER TWO)

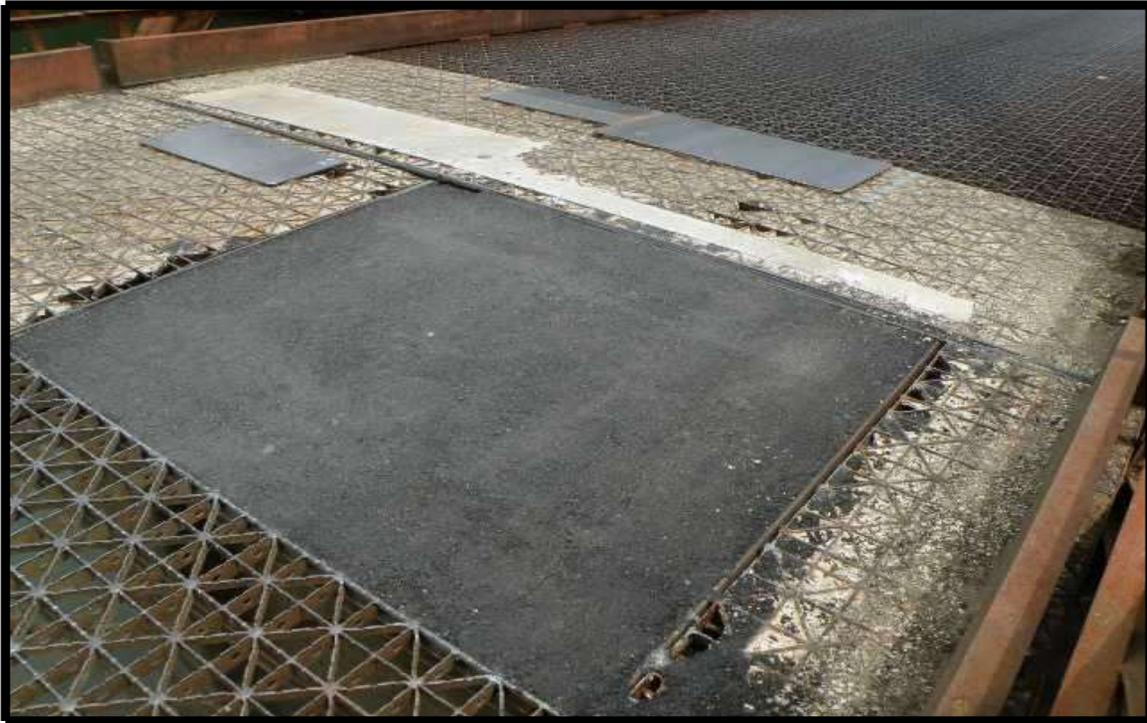
PHOTO 61 - SECTION OF EXPANSION DAM THAT HAS BEEN REMOVED @ PIER ONE

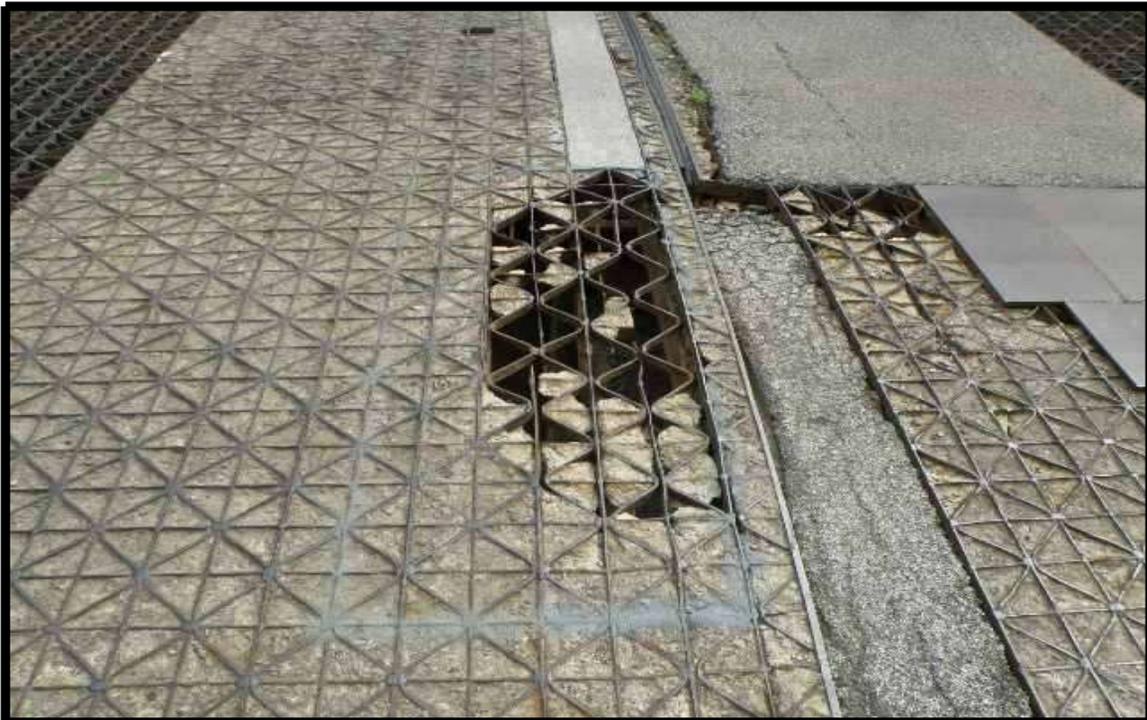
PHOTO 62 - SEVERELY DETERIORATED BEARING BARS IN AREAS NEAR THE SUBSTRUCTURES WHICH HAVE NOT BEEN REPAIRED

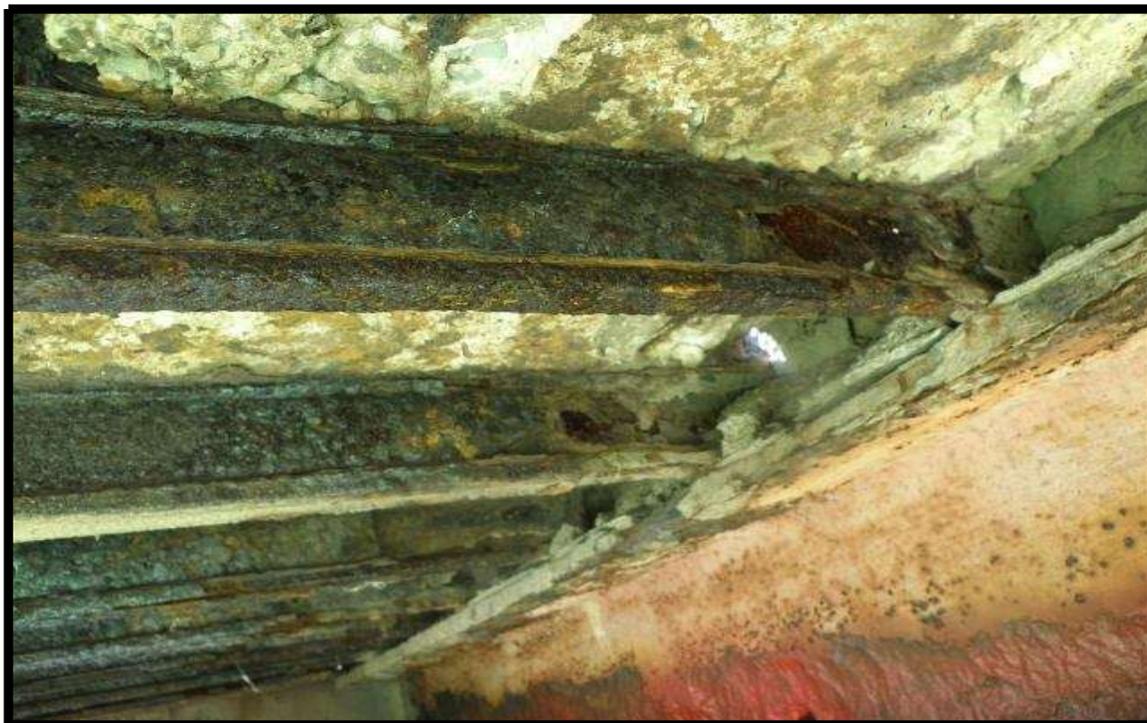
PHOTO 63 - TEMPORARY REPAIRS TO GRID DECK @ PIER ONE

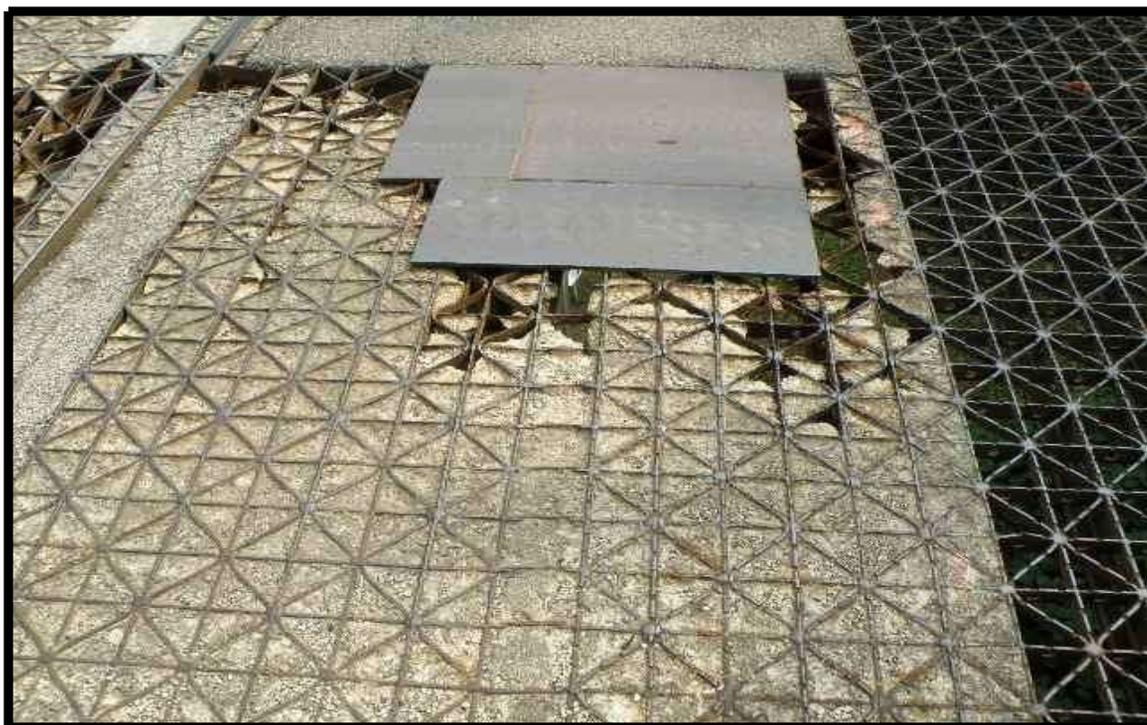
PHOTO 64 - PREVIOUS REPAIR @ ABUTMENT TWO (DETERIORATING BLACKTOP)

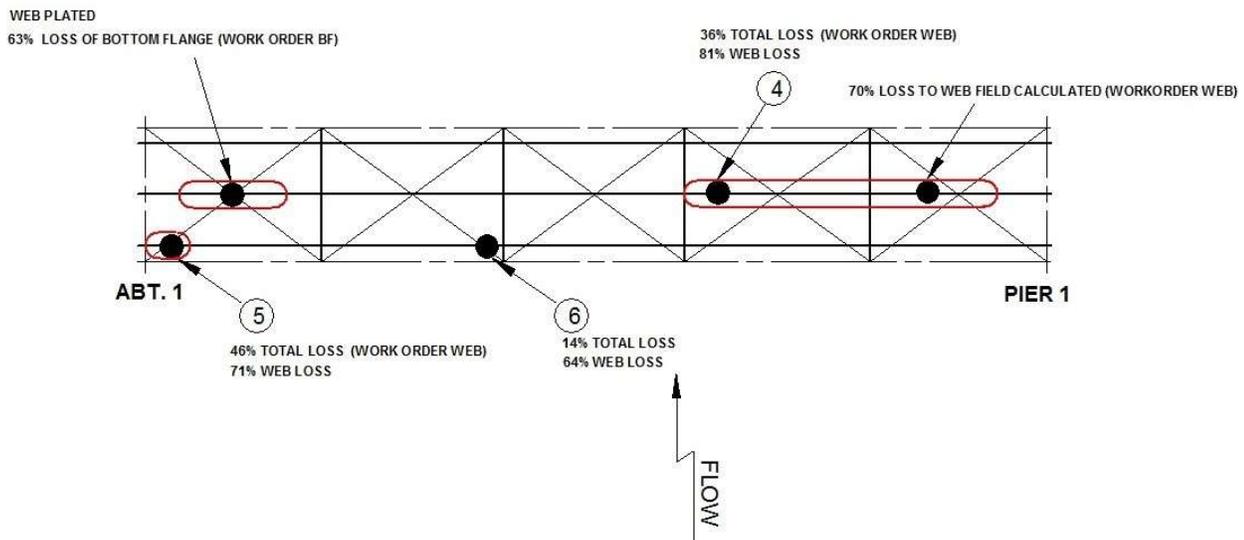
SKETCH #1

The stringers are deteriorated throughout the structure (see **Location Sketch Sheets, SL 1 thru 3**). (**DT SKETCHES 4 THRU 9**)

LOCATION of FLOORSYSTEM DETERIORATION SPAN ONE

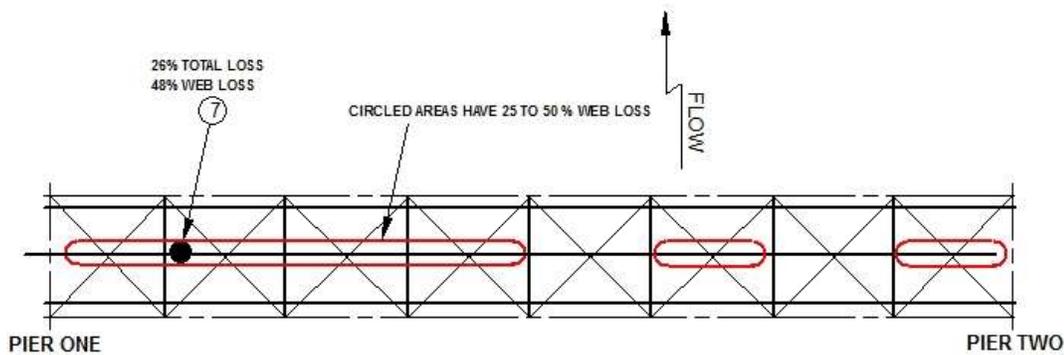
SKETCH #2

STRINGER #2 HAS WEB LOSS (PRIMARILY TO THE UPSTREAM SIDE) RANGING FROM 35% TO 50% FOR ALL PANELS IN SPAN TWO WITH THE EXCEPTION OF PANELS 5 & 7
 BOTH THE TOP AND BOTTOM FLANGES HAVE VERY LITTLE DETERIORATION (TOTAL LOSS OF MEMBER IS IN THE 10% RANGE) NO WORK ORDER IS BEING SUBMITTED AT HIS TIME
 STRINGERS ONE & THREE HAVE A RANDOM AREAS OF DETERIORATION UP TO 25% OF THE WEB, BUT NEARLY NO LOSS TO FLANGES (TOTAL LOSS IN THE 5% RANGE)

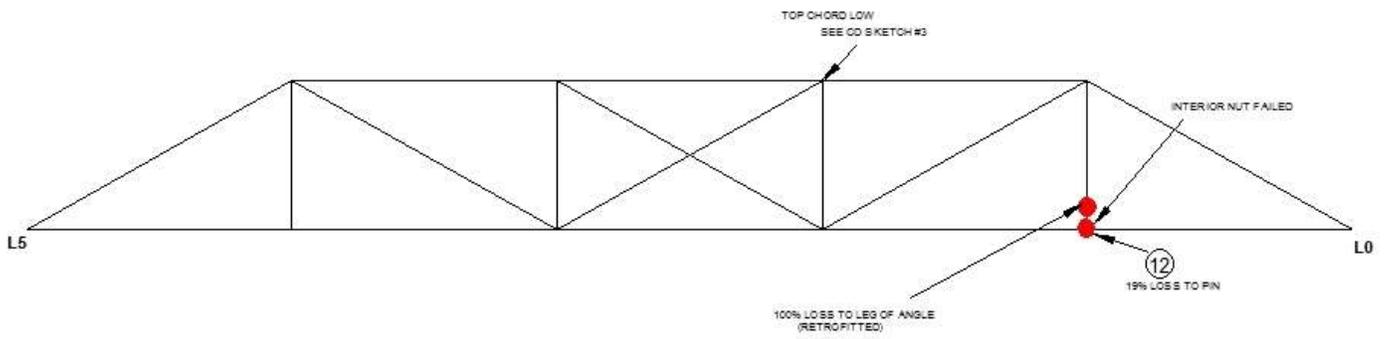
SKETCH#8

TRUSS MEMBER DETERIORATION DOWNSTREAM TRUSS SPAN ONE

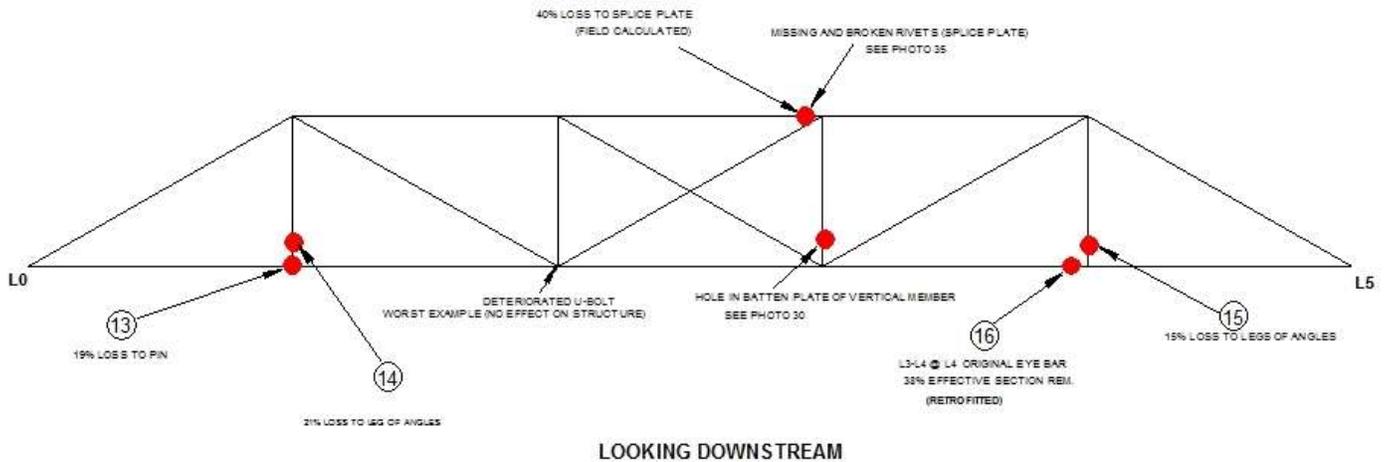
SKETCH#9

TRUSS MEMBER DETERIORATION UPSTREAM TRUSS SPAN ONE

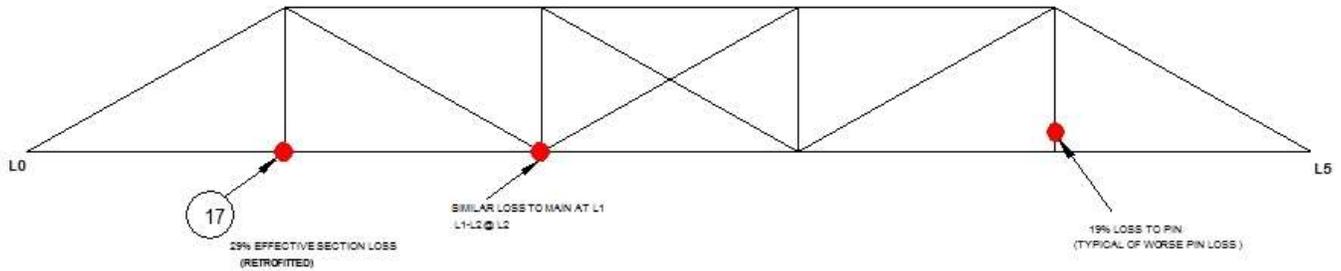
SKETCH # 10

The Pins are in fair condition being moderately deteriorated; with documented loss up to 19% at L1 of Span Ones Downstream Truss (see **Photo 31 and Sketch 10**). The pin at L1 of the Span Ones Downstream Truss displays a similar loss as does the pin at L4 of the Span Threes Upstream Truss.

TRUSS MEMBER DETERIORATION
UPSTREAM TRUSS
SPAN THREE

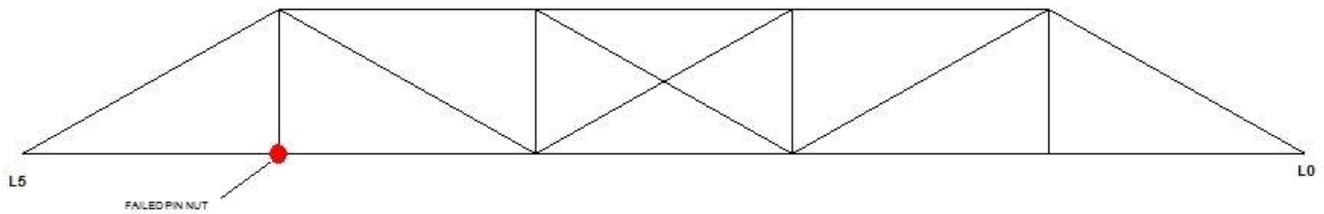
SKETCH#11

TRUSS MEMBER DETERIORATION
DOWNSTREAM TRUSS
SPAN THREE

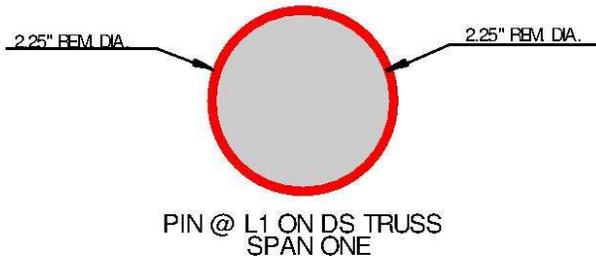
By: FMjr	Date: 6/7/06	Ckd. By: H.O	Date: 7/12/12	Bridge No. 08-4/5-2.95
SPAN: ONE	MEMBER: PIN @L1 DSS	LOCATION: @L1 USS OF PIN		
DESIGNATION: LOWER CHORD PIN	DIMENSIONS: 2 1/2" DIA.			EXTENT: 3/4"

<i>UNIFORM LOSS CALCULATOR</i>			
ORIG. DIAMETER -	2.5	REM. DIAMETER -	2.25
RADIUS -	1.25	RADIUS-	1.13
AREA LOST =		0.93	
% LOSS =		19.00%	
<i>SEGMENT LOSS CALCULATOR</i>			
DIAMETER -		HEIGHT	
RADIUS -	0.00		
SEGMENT AREA LOST =		#DIV/0!	
% LOSS =		#DIV/0!	
UNIFORM & SEGMENT AREA LOSSES			#DIV/0!
TOTAL COMBINED % LOSS			#DIV/0!

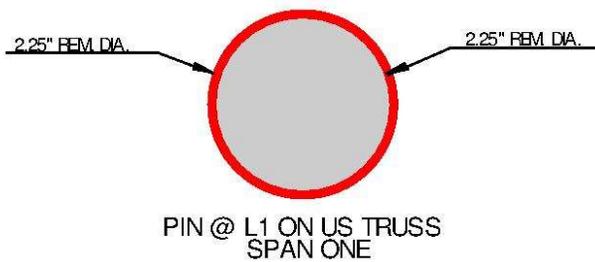
By: H.O	Date: 7/12/12	Ckd. By: P.K	Date: 7/12/12	Bridge No. 08-4/5-2.95
SPAN: ONE	MEMBER: PIN@L1 US	LOCATION: @ L1		
DESIGNATION: LOWER CHORD PIN	DIMENSIONS: 2 1/2" DIA.			EXTENT: 3/4"

<i>UNIFORM LOSS CALCULATOR</i>			
ORIG. DIAMETER -	2.5	REM. DIAMETER -	2.25
RADIUS -	1.25	RADIUS-	1.13
AREA LOST =		0.93	
% LOSS =		19.00%	
<i>SEGMENT LOSS CALCULATOR</i>			
DIAMETER -		HEIGHT	
RADIUS -	0.00		
SEGMENT AREA LOST =		#DIV/0!	
% LOSS =		#DIV/0!	
UNIFORM & SEGMENT AREA LOSSES			#DIV/0!
TOTAL COMBINED % LOSS			#DIV/0!

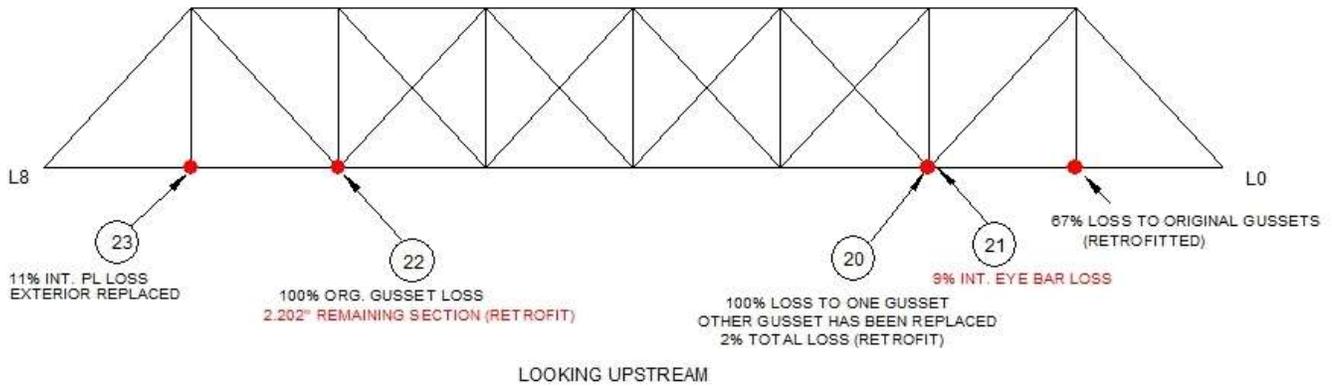
SKETCH #18

TRUSS MEMBER DETERIORATION
DOWNSTREAM TRUSS
SPAN TWO
