Bridge No. 008-4/5-2.95(01215)

PFC Abraham G. Sams Memorial Bridge

over ELK RIVER

BRIDGE INSPECTION REPORT

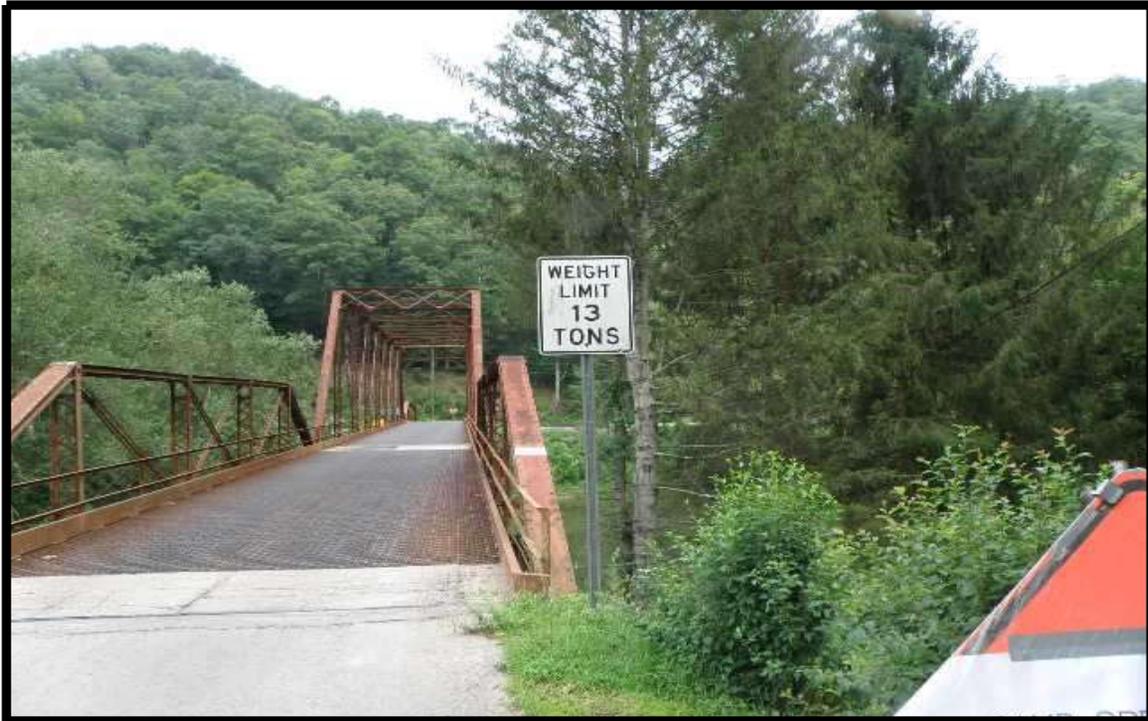
The structure is posted for 13 tons in accordance with a Commissioner's Order dated December 24, 1987 currently on file (see **Photos 3 and 4**). The posting, to the best of our knowledge, is being obeyed.

PHOTO 3 - POSTING SIGN @ ABUTMENT ONE APPROACH

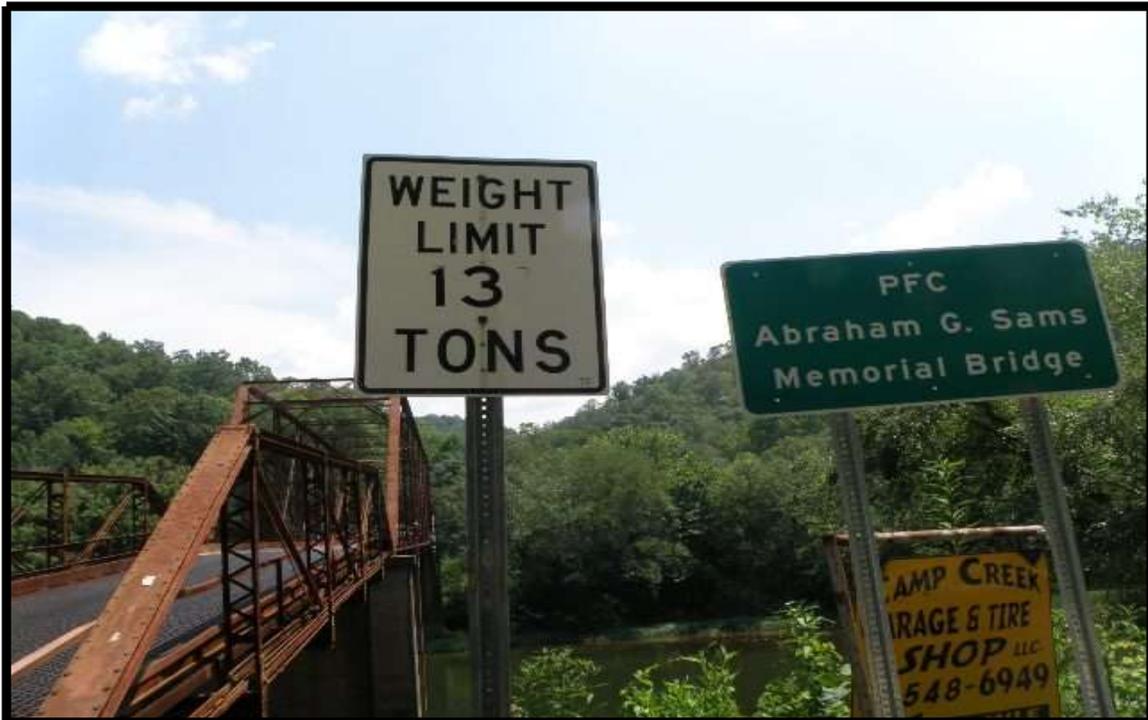
PHOTO 4 - POSTING SIGN @ ABUTMENT TWO APPROACH

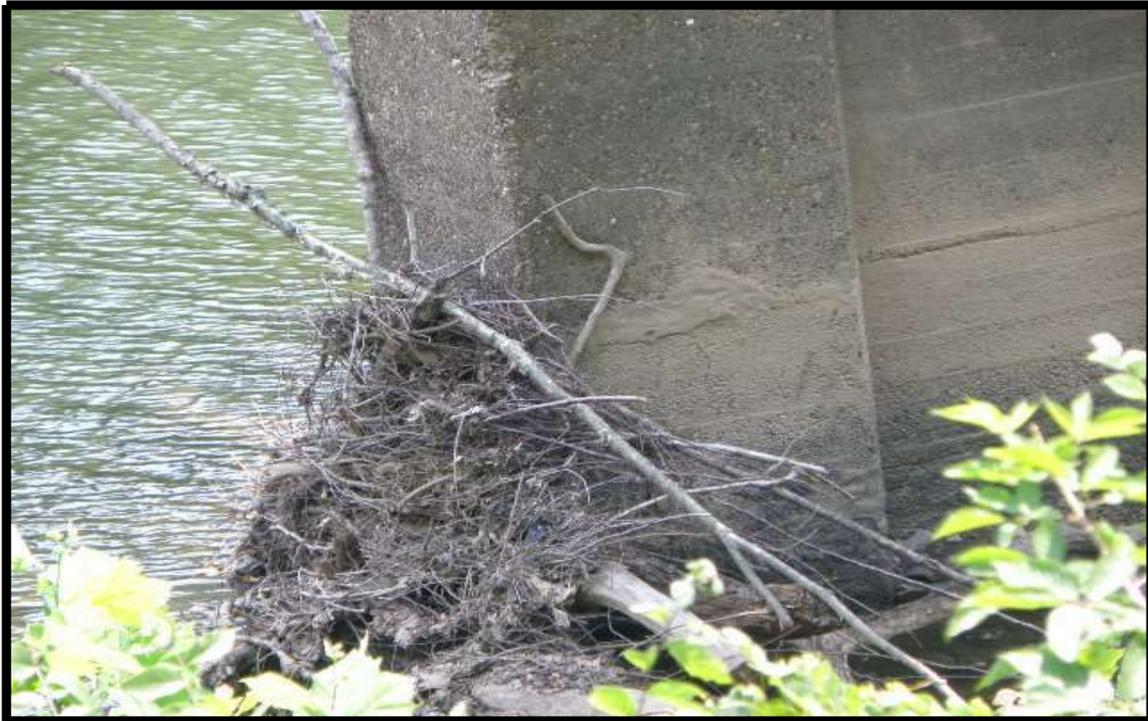
Divers from Materials Control Soil and Testing have removed this structure from their inspection schedule due to the low water conditions usually found. The water was shallow and clear at each substructure during our inspection; we found no scour or undercutting around the piers. We did, however, find a moderate amount of debris accumulated at the upstream end of Pier Two, the only substructure in the water during our inspection (see **Photo 5**).

PHOTO 5 - MODERATE AMOUNT OF DEBRIS AGAINST PIER TWO

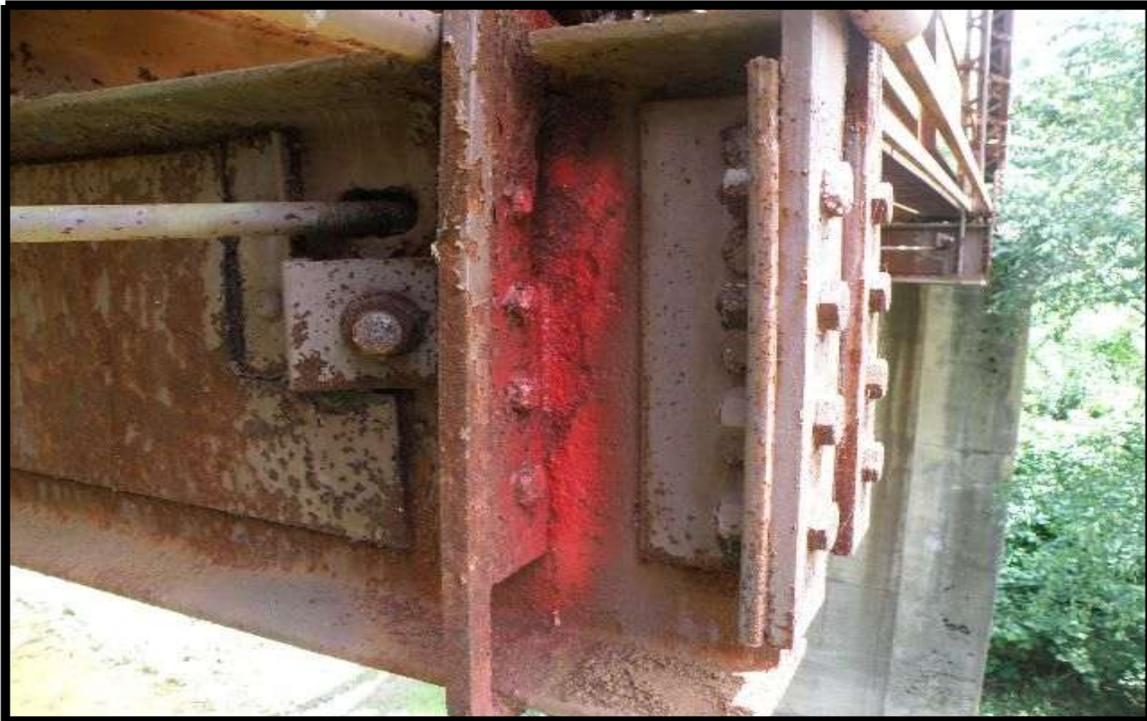
PHOTO 15 - MODERATE LOSS TO FLOORBEAM TWO, SPAN TWO

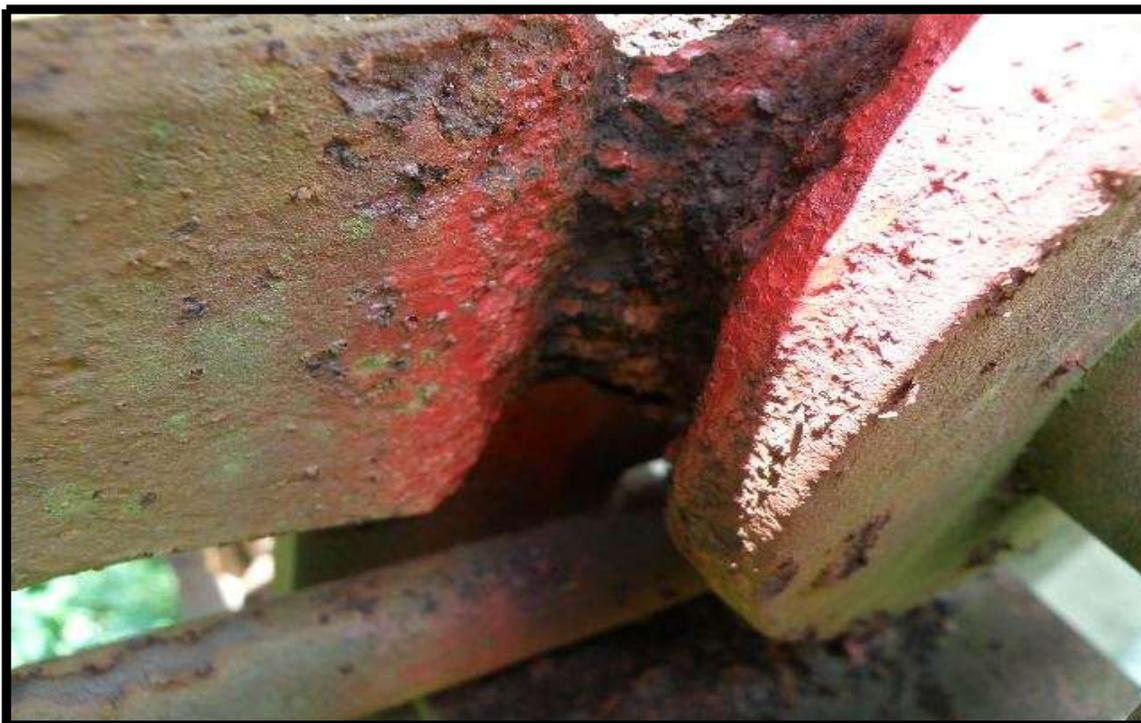
(main) has 61% Loss (38.6 % remaining section) and Span Threes Upstream Truss, L1 – L2 @ L2 exterior eye bar has 28% Loss (71.6 remaining section). L4 – L5 @ L4 interior eye bar also of Span Threes upstream truss has similar effective loss as those at L2 (see **Photos 22 thru 25**).

PHOTO 22 - L3-L4 @ L4 EYE BAR, SPAN ONES UPSTREAM TRUSS (61% LOSS TO MAIN) RETROFITTED

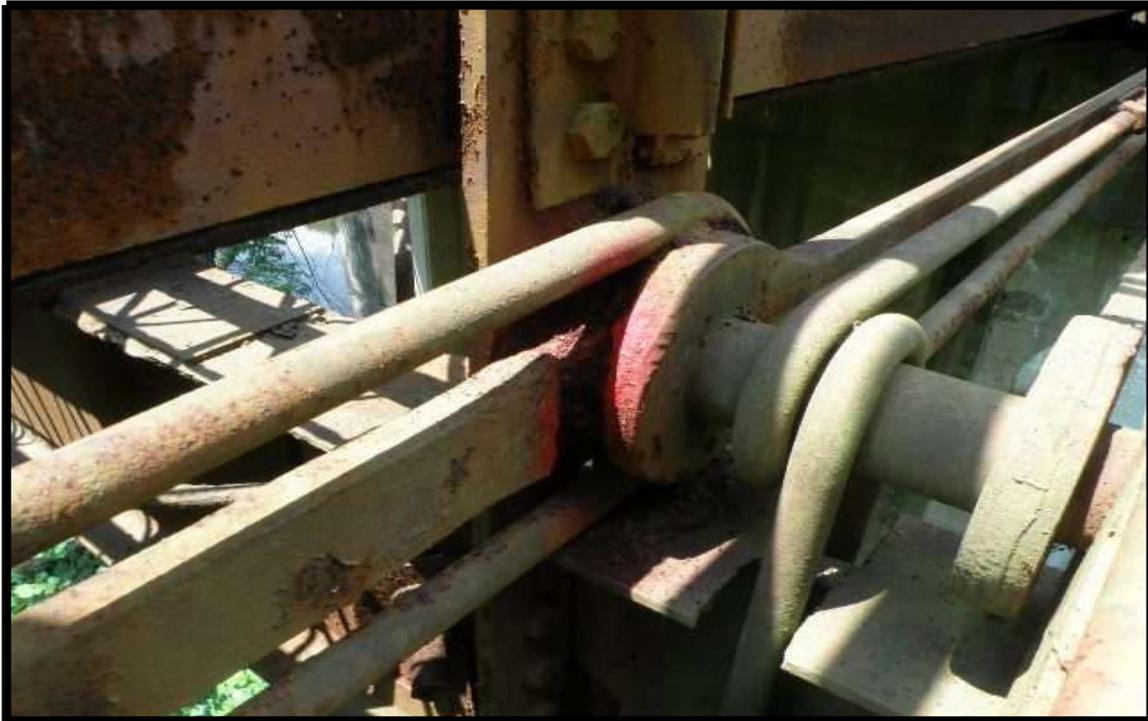
PHOTO 23 - L3 -L4 @ L4 EYE BAR, SPAN ONES UPSTREAM TRUSS (SAME AS PHOTO 13 FOR LOCATION PURPOSES)

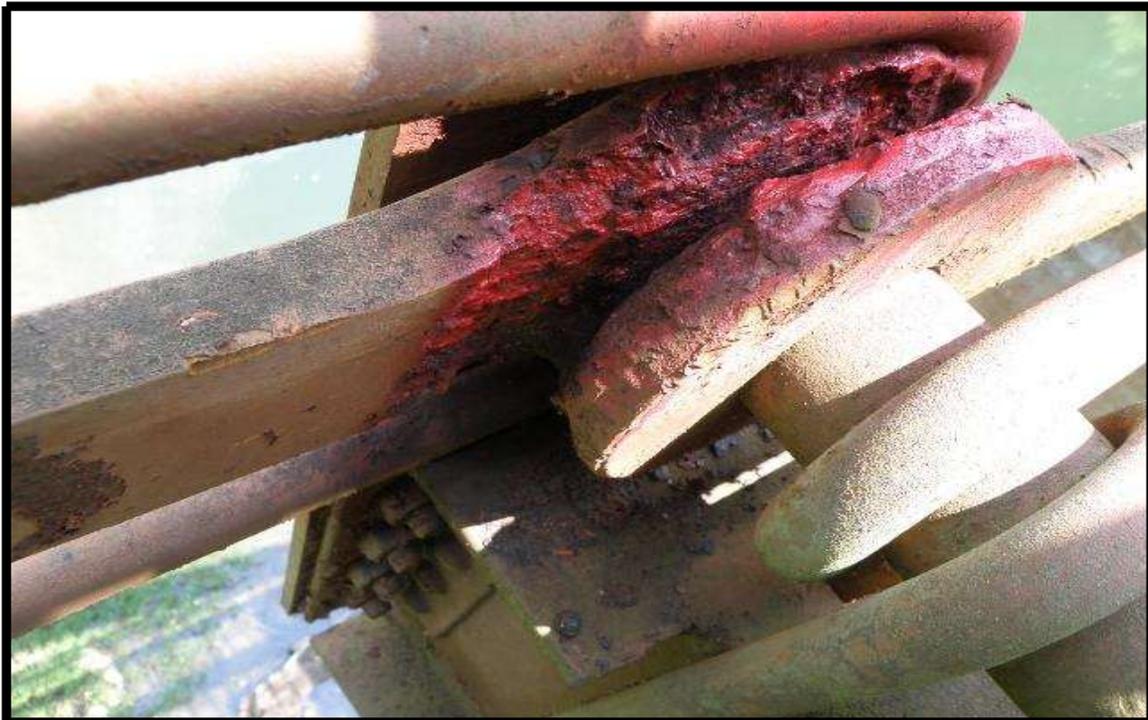
PHOTO 24- L1 - L2 @ L1 EYE BAR, SPAN THREES UPSTREAM TRUSS (61% LOSS TO MAIN) RETROFITTED

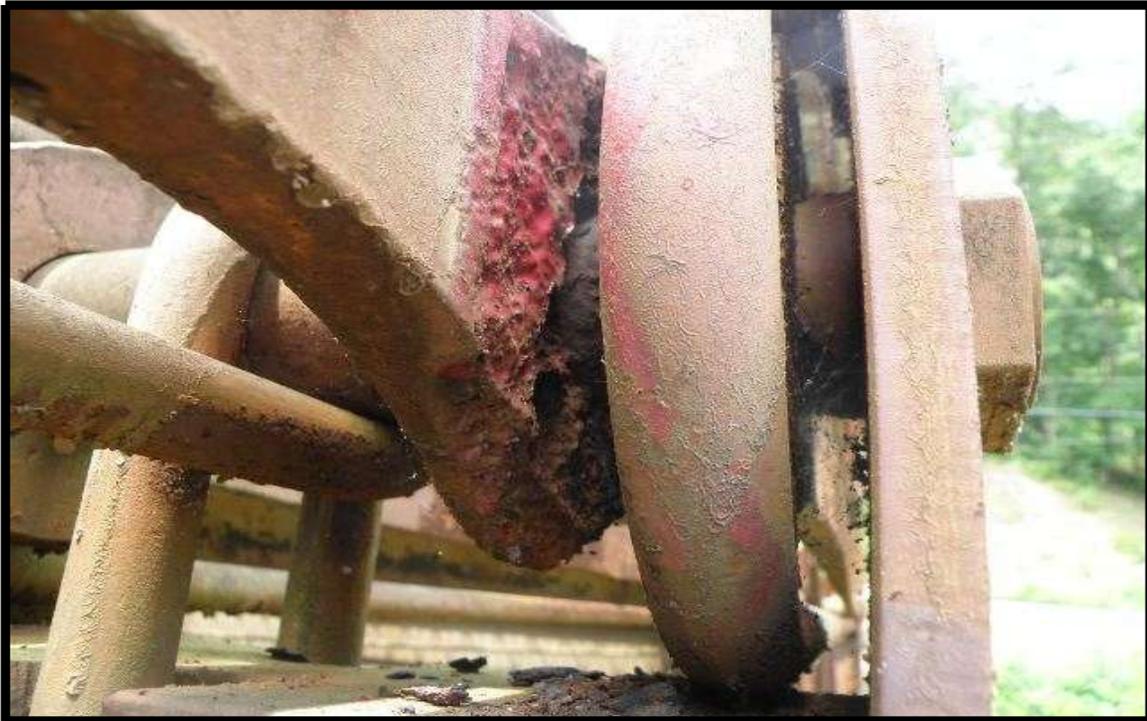
PHOTO 25 - L0 -L1 @ L1 EYE BAR, SPAN THREES UPSTREAM TRUSS (L1 - L2 @L1 SIMILAR EFFECTIVE LOSS)

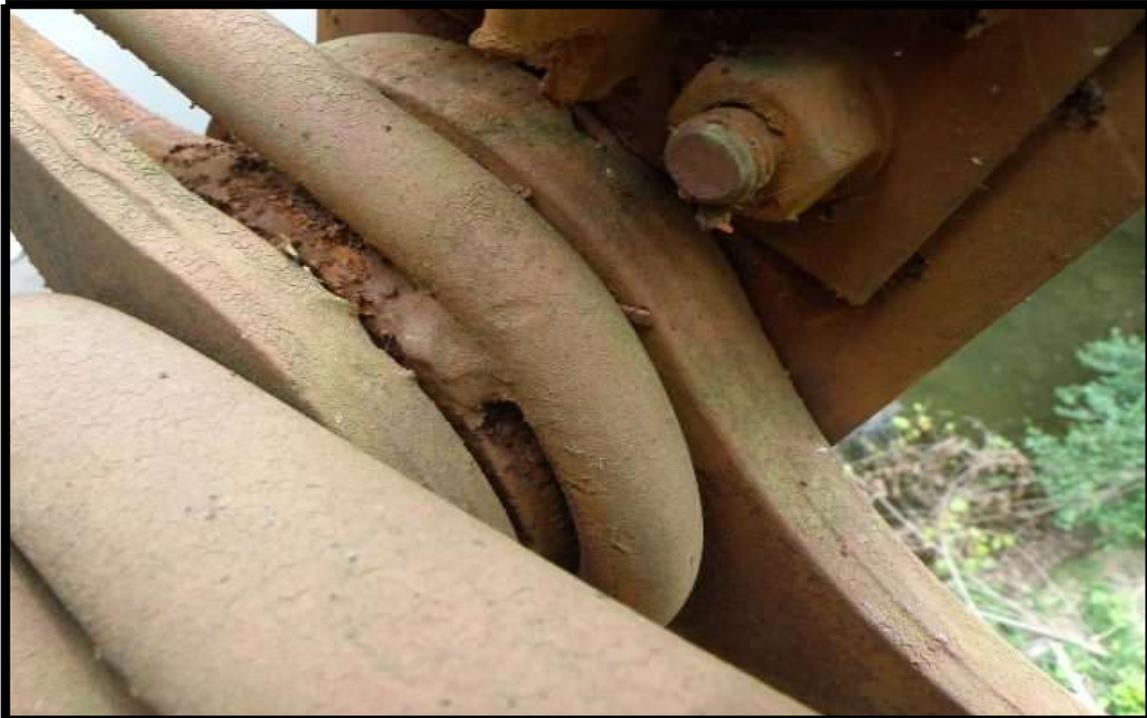
We found spot welds on several of the original eye bars and retrofit loop bars (see **Photo 26**).

PHOTO 26 - EXAMPLE OF WELDS TO LOOP BARS AND ORIGINAL EYE BARS TYPICAL OF ALL SPANS

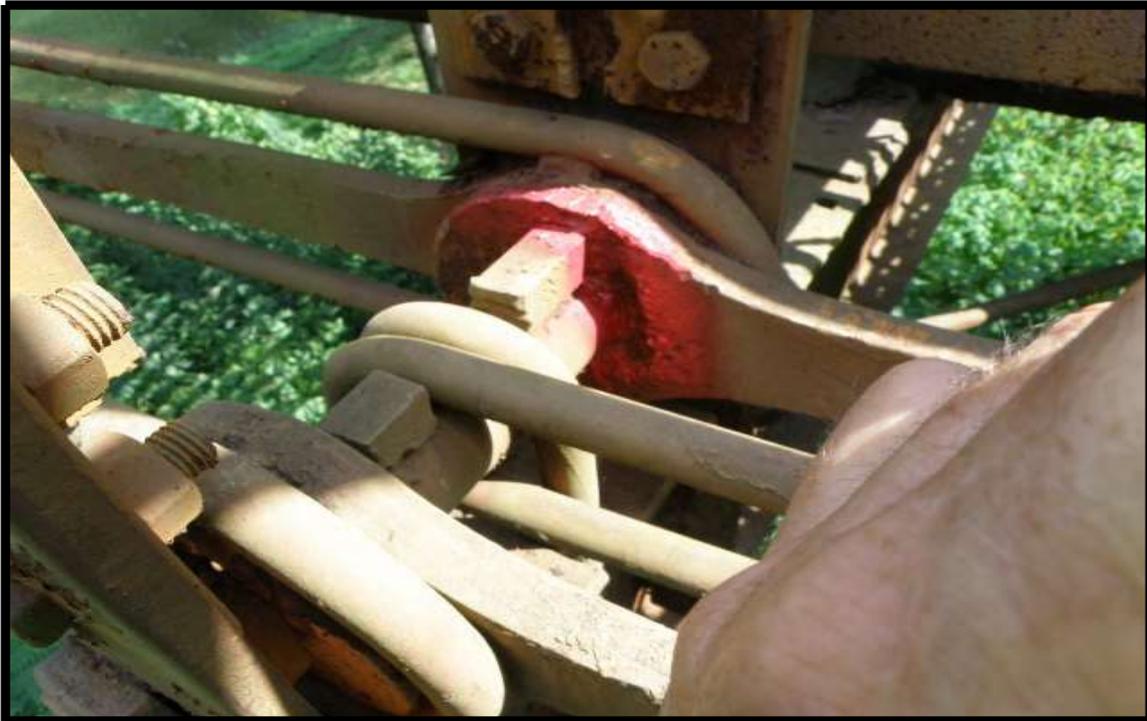
The Pins are in fair condition being moderately deteriorated; with documented loss up to 19% at L1 of Span Ones Downstream Truss (see **Photo 31 and Sketch 10**). The pin at L1 of the Span Ones Downstream Truss displays a similar loss as does the pin at L4 of the Span Threes Upstream Truss.

PHOTO 31 - 19 % SECTION LOSS TO PIN SPAN ONE DOWNSTREAM TRUSS L1

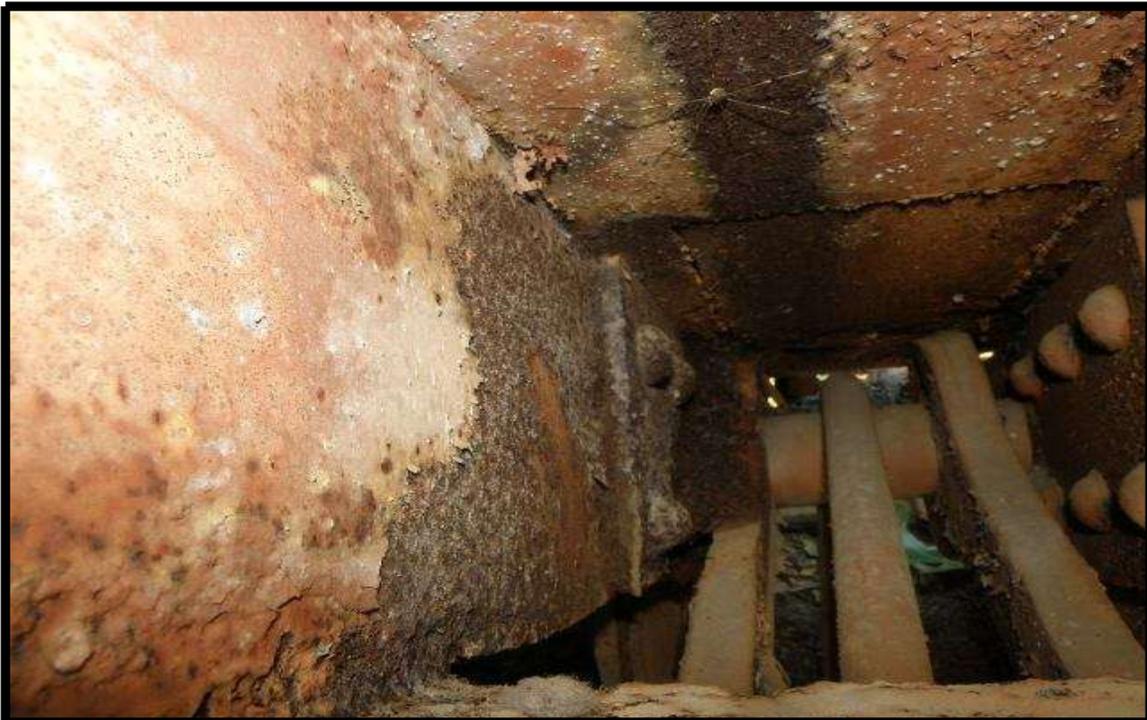
We found some deterioration to the interior of the end post in Span One at U5 upstream and what may have been intentional cuts performed during maintenance to the U5 end post of the downstream truss (see **Photos 32 and 33**) each of these areas are backed up by retrofits and cause no concern at this time.

PHOTO 32 - LOSS TO INT. CHANNEL OF END POST @ L5, SPAN ONES UPSTREAM TRUSS
(HAS CRUDE RETROFIT ON OPPOSITE SIDE OF CHANNEL AND A PLATE ON TOP OF

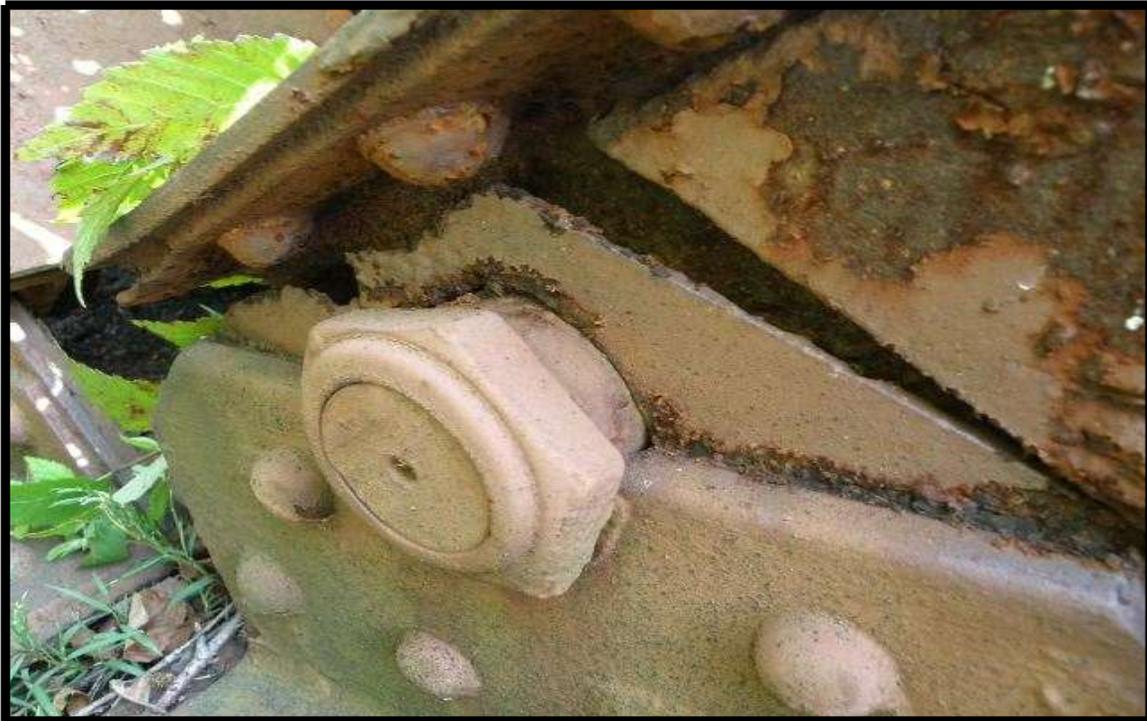
PHOTO 33 - RETROFIT THAT APPEARS TO HAVE BEEN CUT (INTERIOR OF CHANNEL HAS HEAVY PLATE)

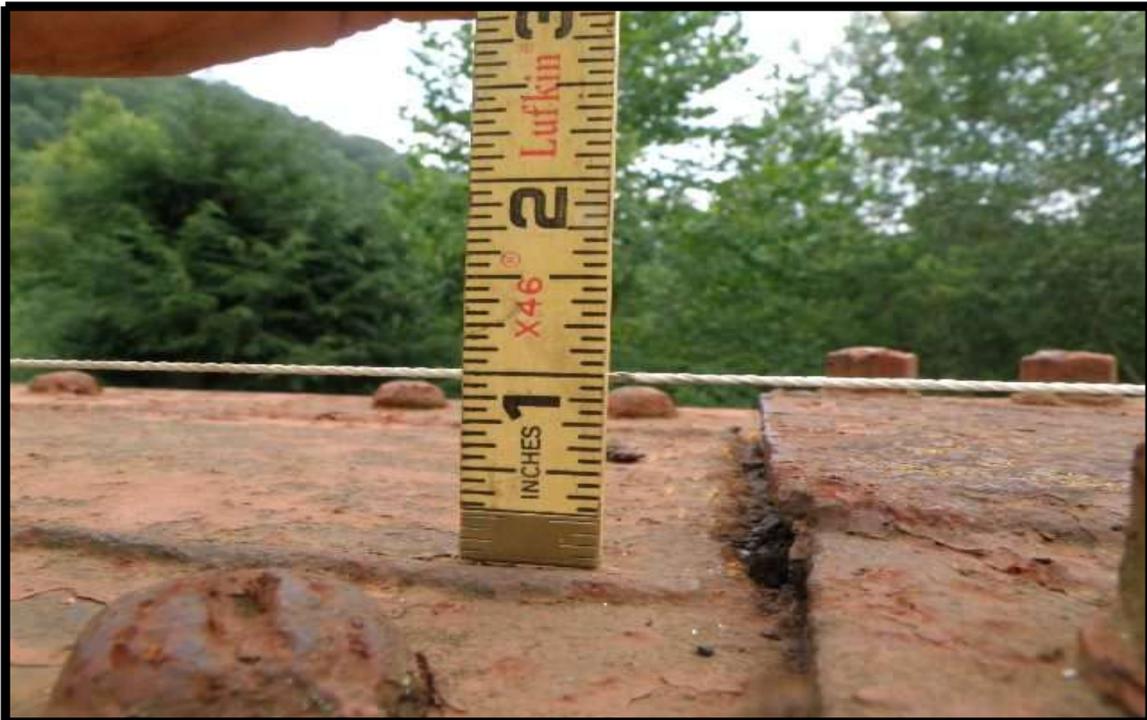
We also found a misalignment in the form a swag to Span Ones Downstream Truss (see **Photo 34**) we recommend monitoring this situation during future inspections (see **CD Sketch 4**).

PHOTO 34 - MEASUREMENT OF HORIZONTAL MISALIGNMENT IN SPAN ONES
DOWNSTREAM TRUSS (SEE SKETCH)

5. Span Ones Downstream Truss should be monitored during each future inspection.
6. Replacement of the frozen roller nests over Pier One and any deteriorated bearing plates is recommended.

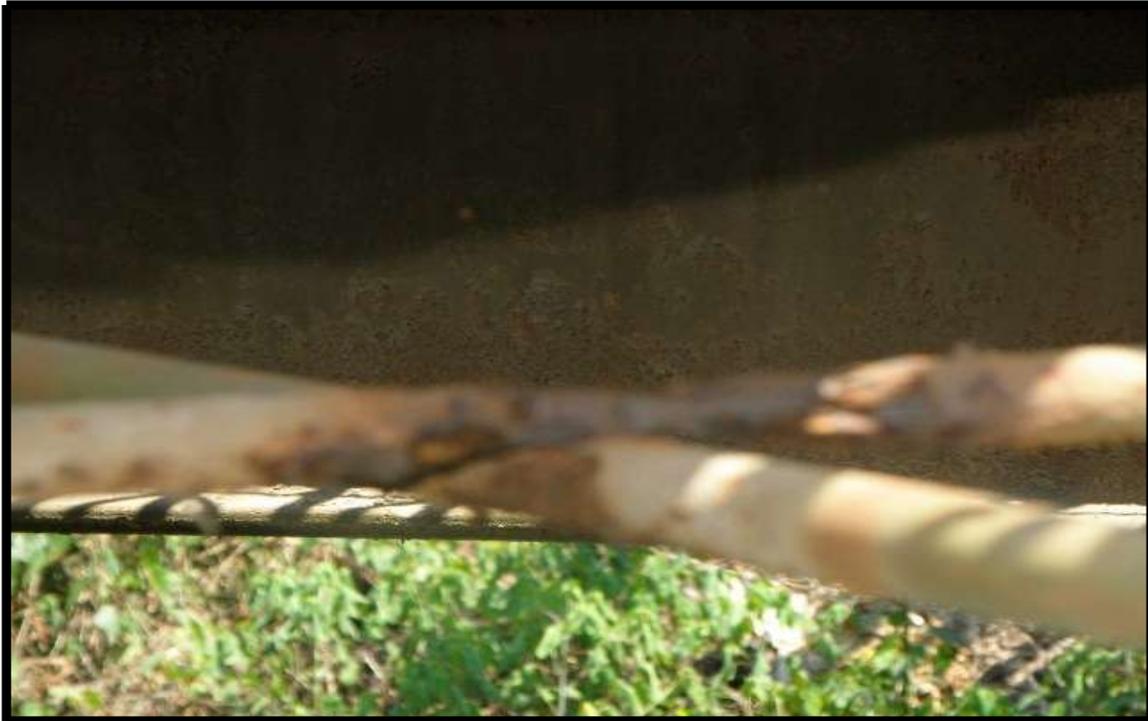
The lower lateral bracing and connections in these spans are in poor condition; with connections at each substructure failing or near failure and heavy deterioration to the lateral members themselves (**see Photo 39 and 40**)

PHOTO 39 - DETERIORATED LATERAL BRACING

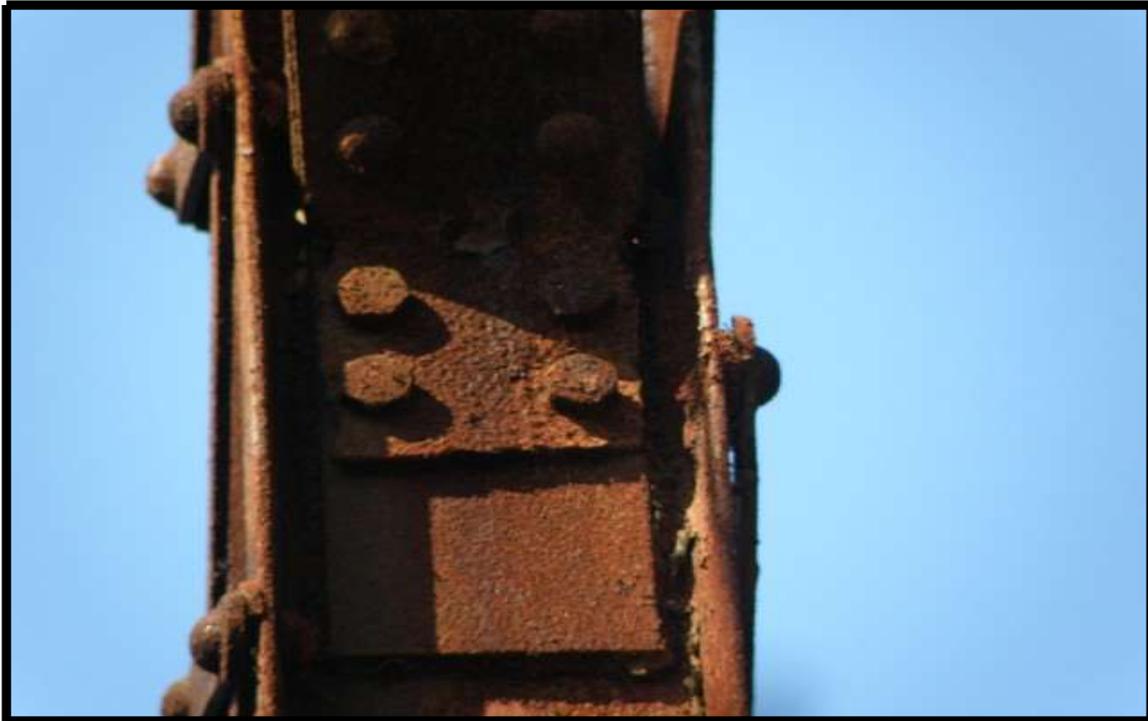
Vertical members in this span are in fair condition; with the hip verticals which are in tension being retrofitted with loop bars. The remaining verticals display minor deterioration around several of the lower connections and holes that have previously been retrofitted on the opposite side at nearly all of the knee brace connections for the upper struts (**see Photo 41**) we could not obtain a good photo of the holes behind each of these plates. These deficiencies should have no effect on load capacity at this time.

PHOTO 41 - RETROFITTED VERTICALS @ KNEE BRACE CONNECTION, 100% LOSS TO INTERIOR VERTICAL BEHIND THIS RETROFIT (TYPICAL)

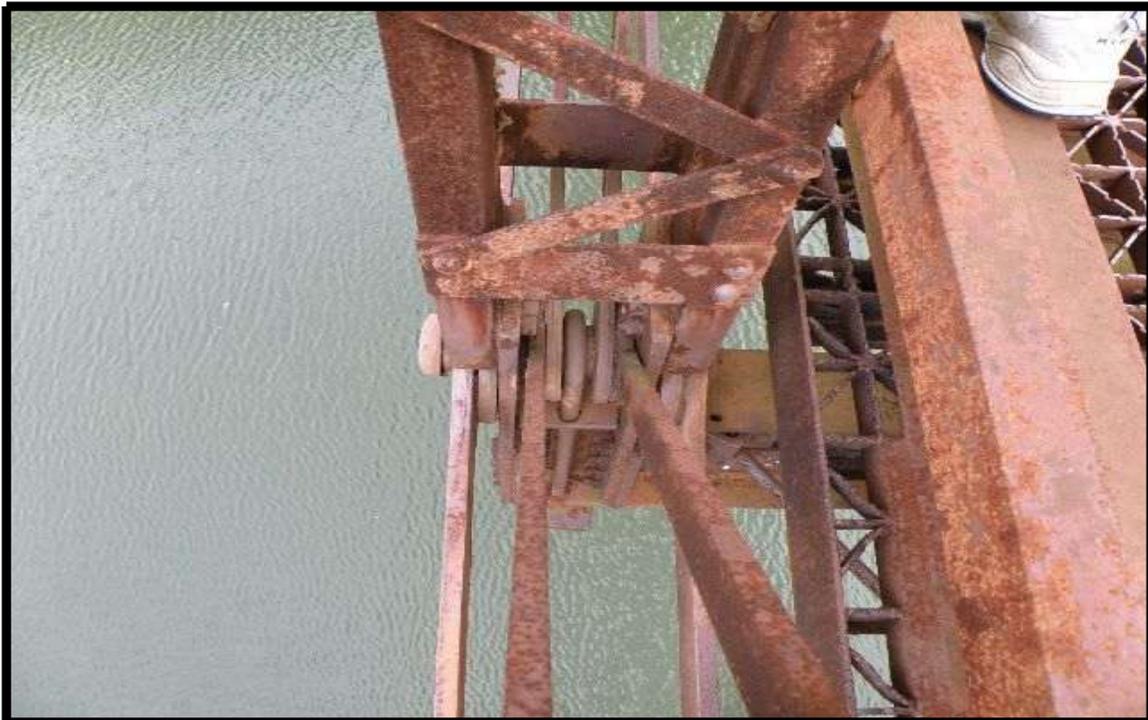
The pins at L4 downstream and L2 upstream are protruding with the nuts not completely installed (**see Photos 42 and 43**) requiring no repair.

PHOTO 42 - PROTRUDING PIN ON EXTERIOR OF LOWER CONNECTION @ L4 DOWNSTREAM SPAN TWO

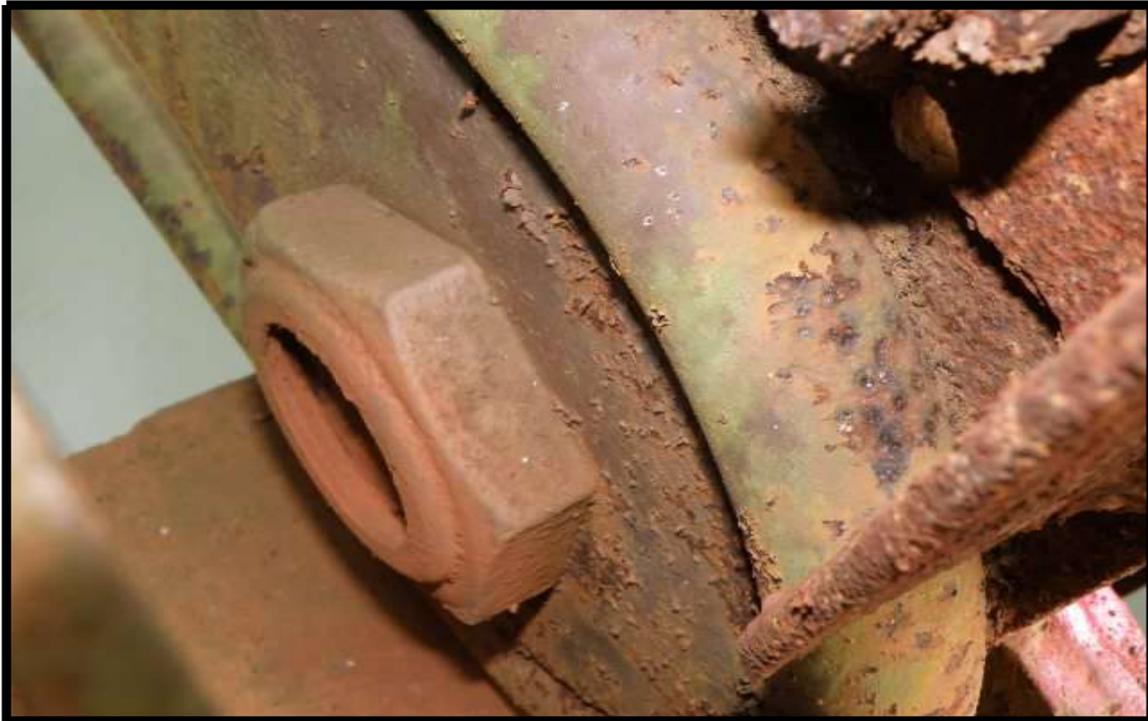
PHOTO 43 - EXPOSED THREADS OF NUT, LOWER CONNECTION @ L2 UPSTREAM SPAN TWO

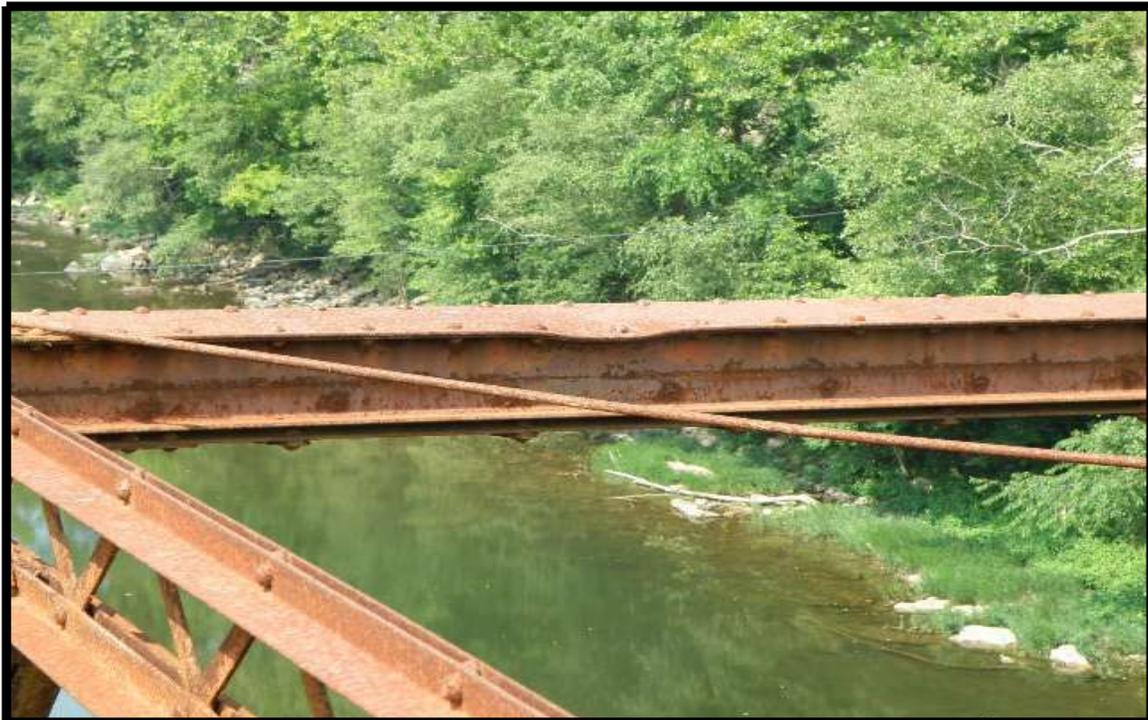
The top chord of the Downstream Truss is damaged in a couple of places with a noticeable sweep in the chord between U2 and U3 (**see Photos 44 and 45**) this misalignment is likely due to construction or renovation damage

PHOTO 44 - UPPER CHORD OF DOWNSTREAM TRUSS SPAN TWO BENT ABOUT 4' FORWARD OF U3

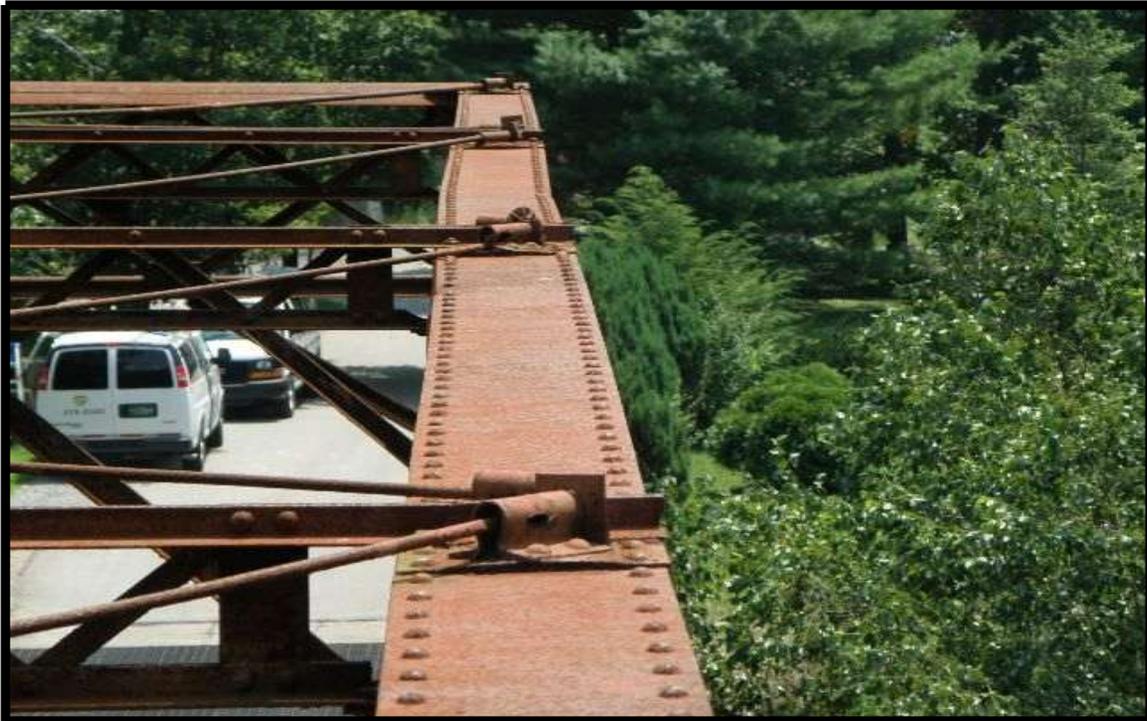
PHOTO 45 - UPPER CHORD OF DOWNSTREAM TRUSS SPAN TWO BENT ON THE EXTERIOR CAUSING A UPSTREAM SWEEP BETWEEN U2 & U3

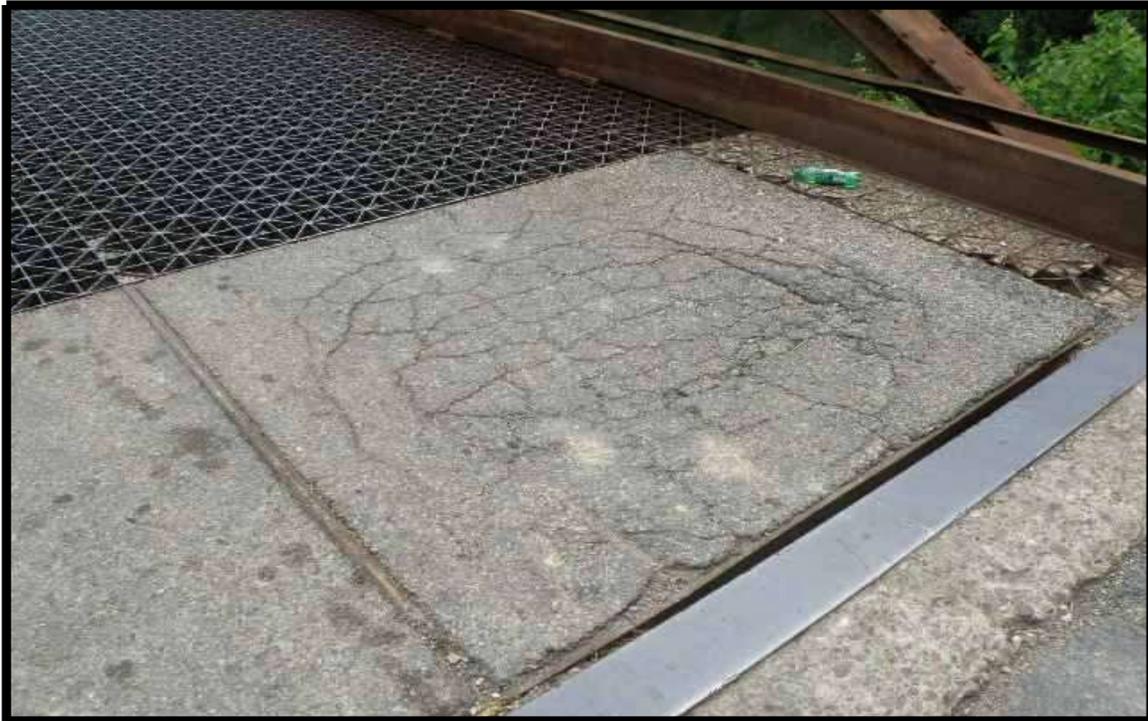
PHOTO 64 - PREVIOUS REPAIR @ ABUTMENT TWO (DETERIORATING BLACKTOP)

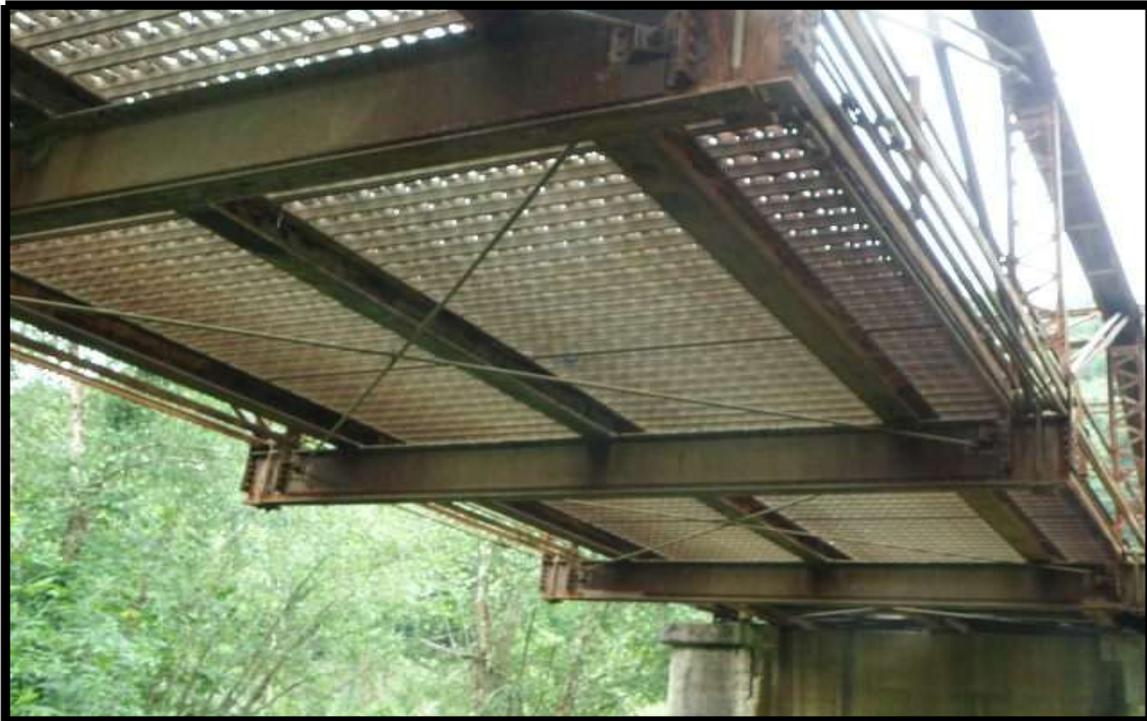
PHOTO 72 - TYPICAL OF RETROFITTED FLOOR BEAMS

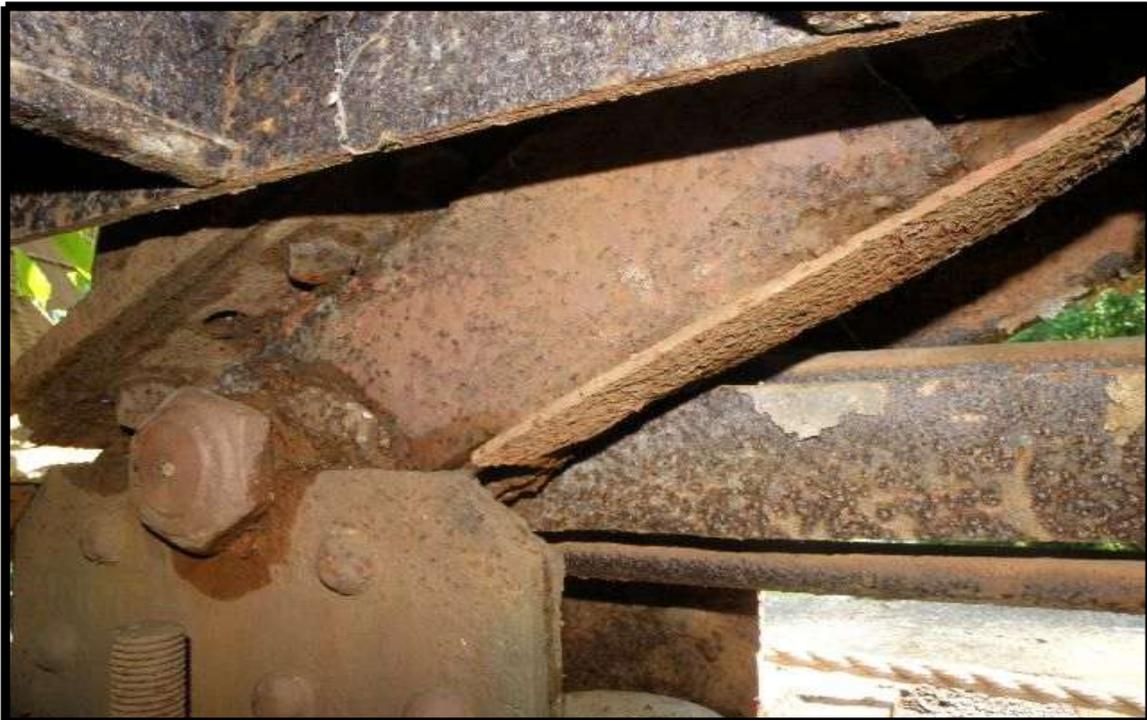
CRUDE RETROFIT TO INTERIOR OF L6 @ PIER 1

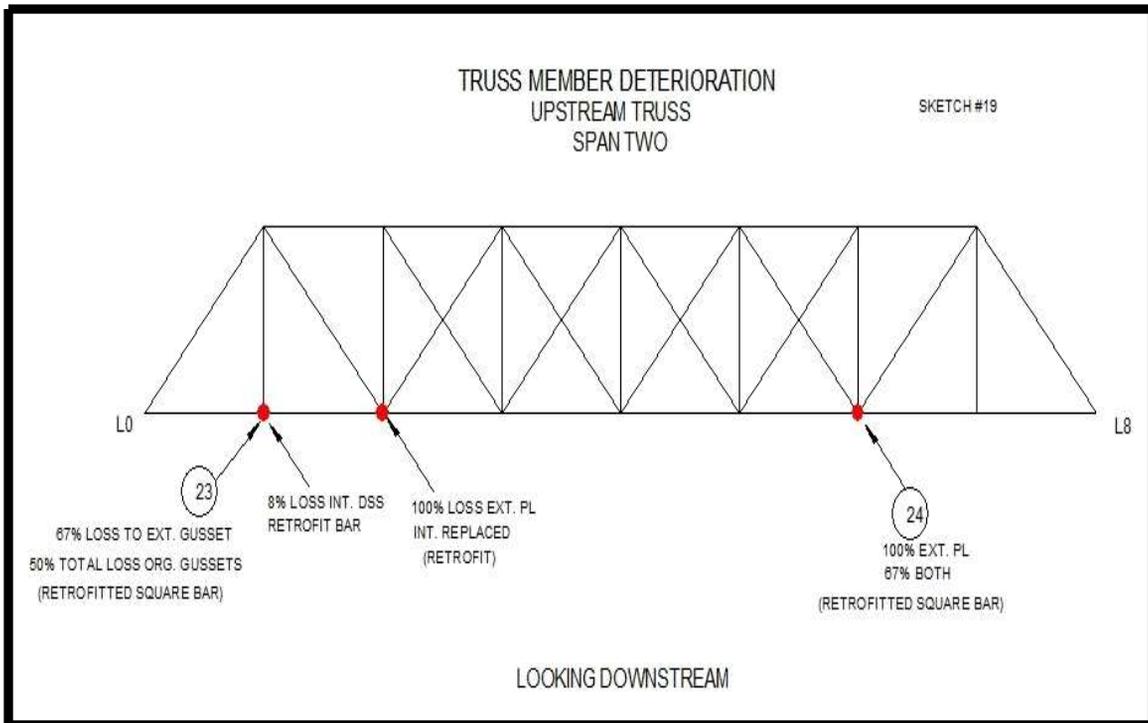
DETERIORATION DETAILS

By: HO	Date: 7/24/12	Ckd. By: PK	Date: 7/24/12	Bridge No. 08-4/5-2.95
SPAN: TWO	MEMBER: RETROFIT	LOCATION: FORWARD SIDE		
US TRUSS	DESIGNATION: INT. BAR DSS	DIMENSIONS: 3/4" SQUARE BAR	EXTENT: 2"

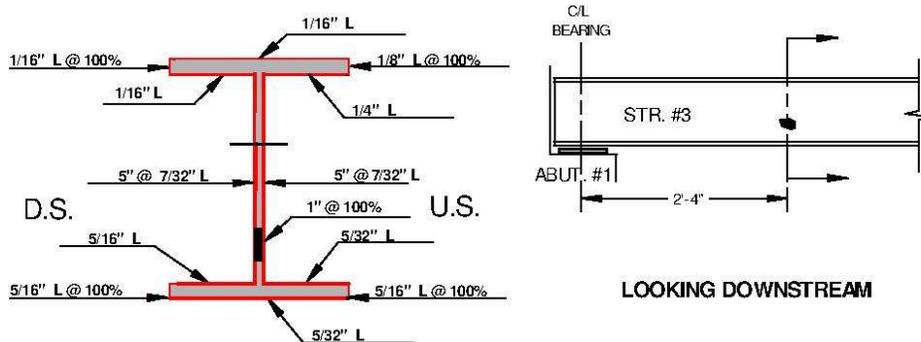
Form DS-28 1-1-90		STRUCTURES DIVISION GENERAL DETERIORATION DETAILS				SKETCH # 5	
By: PK	Date: 7/7/12	Ckd. by: DRB	Date: 7/9/12	Bridge No.: 08-4/5-2.95			
Span	Member	US / DS	Not For Reg. Member		Stringer Panel No:	Stringer No. From L.	Location
			Side	Piece			
ONE	STR.#3		-----	-----	---ONE	-----	NEAR ABUT. 1
Member Designation: W8 X 58			Member Dimensions: 8 3/4' X 8 1/4' X 13/16' X (1/2")			Extent of Deterioration: 5' 6" (END BEAM TO REPAIR PLATE)

TOP FLANGE LOSS		T OF T FLG. REM.		8.033	ORG. HALF FLG.		3.855
Top of Top	LOSS	LENGTH	LOSS	LENGTH	LOSS	LENGTH	AREA ORIG
	DS Btm.	0.063	3.730				AREA FLG
	US Btm.	0.250	3.792				AREA WEB
	DS Tip	0.810	0.063	Hole(s)	Top of Top-All Across	0.063	FLG. THK.
	US Tip	0.810	0.125		Btm of Top-Both Sides		FLG. WIDTH
Top Flange Area Lost			1.835		Top Flange % Lost	28%	DEPTH
WEB LOSS							
	Hole(s)	USS	USS	USS	DSS	DSS	DSS
Length	1.000	5.000	1.130		5.000	1.130	US REM
Loss	0.510	0.219	0.000		0.219	0.000	DS REM
Web Area Lost			2.698		Web % Lost	71%	
BOTTOM FLANGE LOSS		B OF B FLG. REM.		7.595	Total Area Lost		
Bot of Bot	LOSS	LENGTH	LOSS	LENGTH	LOSS	LENGTH	7.886
	DS Btm.	0.313	3.542				Total Member Loss
	US Btm.	0.156	3.542				46%
	DS Tip	0.810	0.313	Hole(s)	Bott of Bott-All Across	0.156	
	US Tip	0.810	0.313		Top of Bott-Both Sides		
Bottom Flange Area Lost			3.353		Bott. Flange % Lost	50%

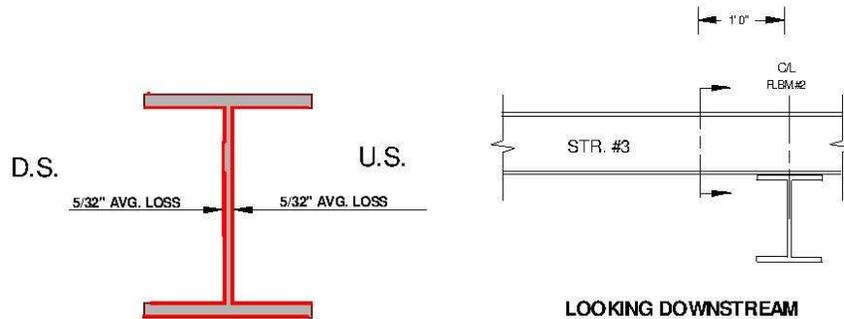
Form DS-28 1-1-90		STRUCTURES DIVISION GENERAL DETERIORATION DETAILS				SKETCH # 6	
By: PK	Date: 7/7/12	Ckd. by: DRB	Date: 7/9/12	Bridge No.: 08-4/5-2.95			
Span	Member	US / DS	Not For Reg. Member		Stringer Panel No:	Stringer No. From L.	Location
			Side	Piece			
ONE	STR.#3		-----	-----	TWO---	-----	1' REAR OF FLBM. #2
Member Designation: W8 X 58			Member Dimensions: 8 3/4' X 8 1/4' X 13/16' X (1/2")			Extent of Deterioration: 2' (TYP. OF SEVERAL LOCATIONS ON STR. 1&3 IN SPAN ONE)

TOP FLANGE LOSS			T OF T FLG. REM.		8.220	ORG. HALF FLG.		3.855
	LOSS	LENGTH	LOSS	LENGTH	LOSS	LENGTH	AREA ORIG	17.100
Top of Top							AREA FLG	6.658
DS Btm.							AREA WEB	3.784
US Btm.							FLG. THK.	0.810
DS Tip	0.810		Hole(s)	Top of Top-All Across			FLG. WIDTH	8.220
US Tip	0.810			Btm of Top-Both Sides			WEB THK.	0.510
Top Flange Area Lost			0.000	Top Flange % Lost		0%	DEPTH	8.750
WEB LOSS								
	Hole(s)	USS	USS	USS	DSS	DSS	DSS	US REM
Length	1.000	6.130			6.130			0
Loss	0.510	0.156			0.156			DS REM
Web Area Lost			2.426	Web % Lost		64%		0
BOTTOM FLANGE LOSS			B OF B FLG. REM.		8.220	Total Area Lost		
	LOSS	LENGTH	LOSS	LENGTH	LOSS	LENGTH	2.426	
Bot of Bot							Total Member Loss	
DS Btm.							14%	
US Btm.								
DS Tip	0.810		Hole(s)	Bot of Bot-All Across				
US Tip	0.810			Top of Bott-Both Sides				
Bottom Flange Area Lost			0.000	Bott. Flange % Lost		0%

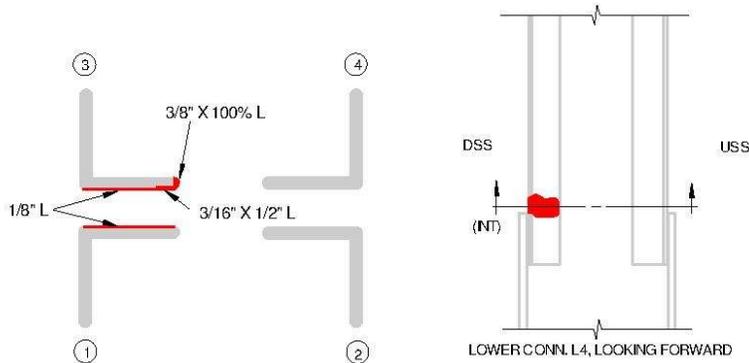
By: FMjr	Date: 6/8/06	Ckd. By: H.O	Date: 7/12/12	Bridge No. 08-4/5-2.95
SPAN: ONE	MEMBER: U4L4 USS	LOCATION: 6" FROM BOTTOM OF MEMBER		
DESIGNATION: L 2 1/2" x 3.62#	DIMENSIONS: 4 ANGLES 2 1/2" x 2" x 1/4"			EXTENT: 3"

ANGLES 1 & 4 SECTION LOSS							AO Total	2.13
Angle 1	Loss	Length	Loss	Length	Loss	Length	AO Per L	1.06
24%							V-LEG	2.500
	0.125	2.000					H-LEG	2.000
Angle 4	Loss	Length	Loss	Length	Loss	Length	Thickness	0.250
0%							# Angles	2.000
							for Angles 1 & 4	
ANGLES 2 & 3 SECTION LOSS							AL Total	0.25
Angle 2	Loss	Length	Loss	Length	Loss	Loss	% Loss	12%
0%								
Angle 3	Loss	Length	Loss	Length	Loss	Length	AO Total	2.13
35%	0.188	0.500	0.125	1.500	0.250	0.375	AO Per L	1.06
							V-LEG	2.500
							H-LEG	2.000
							Thickness	0.250
TOTAL MEMBER LOSS (all angles combined)							# Angles	2.000
							for Angles 2 & 3	
							AL Total	0.38
							% Loss	18%

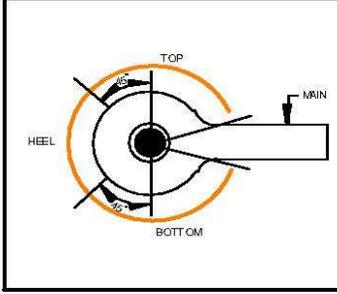
STRUCTURES DIVISION							
EYEBAR DETERIORATION DETAILS							
SKETCH #							
By:	PK	Date:	7/16/2012	Ckd. By:	PK	Date:	7/16/2012
Bridge No.:	08-4/5-2.95						
Span	Member @ End	US/DS	INT./EXT.	End Type	Rect./Sq.	Distance	Location When Not @ Pin Extent
THREE	L1 L2 @ L1	US	EXT	RND	REC.		
Orig. Size:		2 1/2" X 7/8"		Area Remaining:		0.625 X 2.5 1.5625	
MAIN	Orig. Area:	2.1875		Orig. Area Main:	2.1875		
Section Remaining		71.4%		Effective Section Remaining		71.4%	
Orig. Size:		1 3/4" X 1"		Area Remaining:		1.5 X 0.8125 1.21875	
TOP	Orig. Area:	1.75		Orig. Area Main:	1.75		
Section Remaining		69.6%		Effective Section Remaining		103.1%	
Orig. Size:		1 3/4" X 1"		Area Remaining:		1.4375 X 0.8125 1.167969	
BOTTOM	Orig. Area:	1.75		Orig. Area Main:	1.75		
Section Remaining		66.7%		Effective Section Remaining		98.8%	
Orig. Size:		1 3/4" X 1"		Area Remaining:		1.6875 X 0.8125 1.371094	
HEEL	Orig. Area:	1.75		Orig. Area Main:	1.75

Section Remaining		78.3%		Effective Section Remaining		104.2%	
Controlling Section Loss =		smallest section above		71.4	28.60%		
Controlling Effective % Loss =		smallest effective remaining		71.4	28.60%
